Access Compliance Report Public Rights-of-Way (Curb Ramps)

Intersection ID: 18993 Main Street: CHELSEA_BAY_DR Cross Street: ROCK_ISLAND_RD Location: N

ADA ID: 5CE673CCBE81 Ramp Type: PerpDiag Initial Pass/Fail: Fail Overall Compliance: No Severity Score: 60

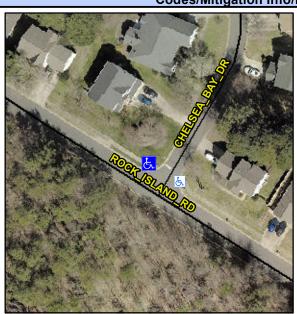
Compliance Description Data Compliance Description Data Yes N/A Ramp Length (in) 100.0 Ramp Slope (%) 5.9 30.0 No Ramp XSlope (%) No Ramp Width (in) 10.8 N/A N/A Flare Type LT N/A Flare Type RT N/A N/A N/A N/A Flare Slope RT (%) N/A Flare Slope LT (%) N/A Flare Traversable LT? N/A N/A Flare Traversable RT? N/A N/A N/A N/A **DWS Provided?** N/A Landing Length (in) N/A Landing Width (in) N/A N/A **DWS Contrast?** N/A N/A N/A N/A Landing Slope (%) DWS Length (in) N/A N/A Landing X Slope (%) N/A N/A DWS Full Width? N/A N/A Landing Curb? (Y/N) N/A N/A DWS Offset (in) N/A N/A N/A Shared Landing? N/A Gutter Ponding? N/A N/A Gutter Slope (%) N/A N/A Gutter Lip Ht (in) N/A N/A Gutter X Slope (%) N/A N/A Painted X Walk1? No N/A Painted X Walk2? No X Walk 1 Direction To SW X Walk 2 Direction To SE N/A N/A X Walk 1 Width (in) X Walk 2 Width (in) N/A X Walk 1 Slope (%) 9.7 X Walk 2 Slope (%) 3.3 X Walk 1 X Slope (%) 5.5 X Walk 2 X Slope (%) 6.8 N/A N/A N/A Ramp inside XWalk2? N/A Ramp inside XWalk1? Road Slope (%) 4.4 N/A Clear Space? N/A N/A Road X Slope (%) 5.9 Clear Space to XWalk (in) N/A N/A N/A N/A Any Obstructions? Storm Grate/Utility Hazard? N/A **Obstruction Type** Storm Grate/Utility Type N/A N/A Yes Surface Condition? (G/P) Good

Remove & Replace Curb Ramp With Two New Directional Ramps or Equivalent.

R304.5.1, R304.5.3
