Access Compliance Report

Public Rights-of-Way

(Curb Ramps)

Intersection ID: 14846	Main Street: HENLEY_PL	Cross Street: S_KINGS_DR	Location: NE
ADA ID: 5CE7C48BE947	Ramp Type: Perp	Initial Pass/Fail: Fail	Overall Compliance: No
Severity Score: 13.75			
Codes/Mitigation Info/Possible Solution		Field Measurements/Component Compliance

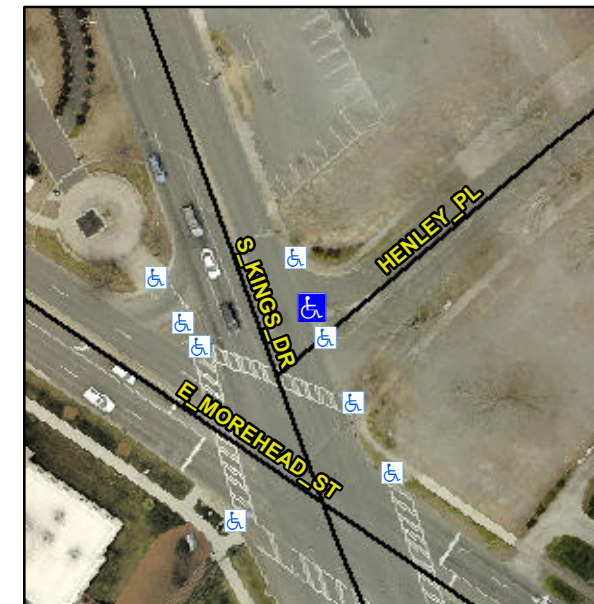
Compliance	Description	Data	Compliance	Description	Data
N/A	Ramp Length (in)	48.0	No	Ramp Slope (%)	8.4
Yes	Ramp Width (in)	48.0	No	Ramp XSlope (%)	4.2
N/A	Flare Type LT	N/A	N/A	Flare Type RT	N/A
N/A	Flare Slope LT (%)	N/A	N/A	Flare Slope RT (%)	N/A
N/A	Flare Traversable LT?	N/A	N/A	Flare Traversable RT?	N/A
N/A	Landing Length (in)	N/A	N/A	DWS Provided?	N/A
N/A	Landing Width (in)	N/A	N/A	DWS Contrast?	N/A
N/A	Landing Slope (%)	N/A	N/A	DWS Length (in)	N/A
N/A	Landing X Slope (%)	N/A	N/A	DWS Full Width?	N/A
N/A	Landing Curb? (Y/N)	N/A	N/A	DWS Offset (in)	N/A
N/A	Shared Landing?	N/A			
N/A	Gutter Ponding?	N/A	N/A	Gutter Slope (%)	N/A
N/A	Gutter Lip Ht (in)	N/A	N/A	Gutter X Slope (%)	N/A
N/A	Painted X Walk1?	No	N/A	Painted X Walk2?	N/A
	X Walk 1 Direction	To N		X Walk 2 Direction	N/A
N/A	X Walk 1 Width (in)	N/A	N/A	X Walk 2 Width (in)	N/A
	X Walk 1 Slope (%)	0.0		X Walk 2 Slope (%)	N/A
	X Walk 1 X Slope (%)	3.7		X Walk 2 X Slope (%)	N/A

N/A	Ramp inside XWalk1?	N/A	N/A	Ramp inside XWalk2?	N/A
	Road Slope (%)	N/A	N/A	Clear Space?	N/A
	Road X Slope (%)	N/A	N/A	Clear Space to XWalk (in)	N/A
N/A	Any Obstructions?	N/A	N/A	Storm Grate/Utility Hazard?	N/A
	Obstruction Type			Storm Grate/Utility Type	
		N/A			N/A
		Yes		Surface Condition? (G/P)	Good

Remove & Replace Entire Ramp.

R304.2.2, R304.5.3
