# Access Compliance Report

## Public Rights-of-Way

### (Curb Ramps)

Intersection ID: N/A	Main Street: GLEN_LAKE_DR	Cross Street: CASCADE_POINTE_BV	Location: SE
ADA ID: 5CEC934878CA	Ramp Type: MedianPerp	Initial Pass/Fail: Pass	Overall Compliance: No
Codes/Mitigation Info/Possible Solution		Field Measurements/Component Compliance	
Severity Score: 10

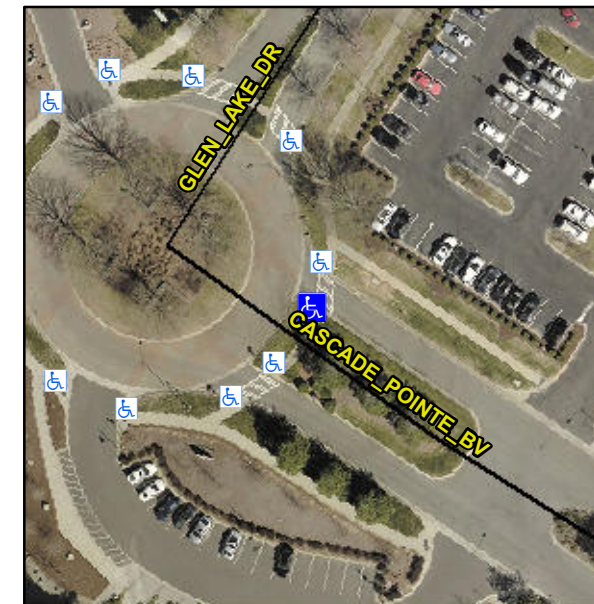
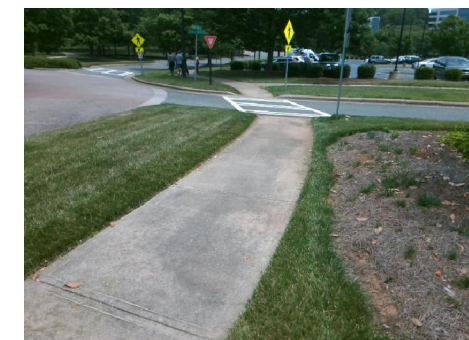
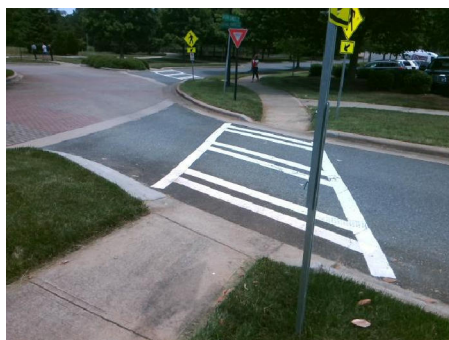
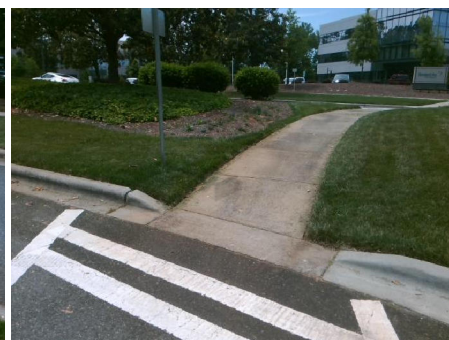
**Not Found, R304.2.2-Perp, R304.3.2-  
Para, R305, R304.5.3**

Compliance	Description	Data	Compliance	Description	Data
N/A	Ramp Length (in)	263.0	Yes	Ramp Slope (%)	6.8
Yes	Ramp Width (in)	59.0	Yes	Ramp XSlope (%)	2.0
N/A	Flare Type LT	None	N/A	Flare Type RT	N/A
N/A	Flare Slope LT (%)	N/A	N/A	Flare Slope RT (%)	N/A
N/A	Flare Traversable LT?	N/A	N/A	Flare Traversable RT?	N/A
Yes	Landing Length (in)	80.0	No	DWS Provided?	No
Yes	Landing Width (in)	60.0	N/A	DWS Contrast?	No
No	Landing Slope (%)	2.8	N/A	DWS Length (in)	N/A
Yes	Landing X Slope (%)	1.2	N/A	DWS Full Width?	No
N/A	Landing Curb? (Y/N)	N/A	N/A	DWS Offset (in)	N/A
N/A	Shared Landing?	No			
Yes	Gutter Ponding?	No	Yes	Gutter Slope (%)	3.4
Yes	Gutter Lip Ht (in)	0.0	No	Gutter X Slope (%)	2.6
N/A	Painted X Walk1?	Yes	N/A	Painted X Walk2?	N/A
	X Walk 1 Direction	To NE		X Walk 2 Direction	N/A
N/A	X Walk 1 Width (in)	93.0	N/A	X Walk 2 Width (in)	N/A
	X Walk 1 Slope (%)	4.6		X Walk 2 Slope (%)	N/A
	X Walk 1 X Slope (%)	0.8		X Walk 2 X Slope (%)	N/A

Yes	Ramp inside XWalk1?	Yes	N/A	Ramp inside XWalk2?	N/A
	Road Slope (%)	N/A	N/A	Clear Space?	Yes
	Road X Slope (%)	N/A	N/A	Clear Space to XWalk (in)	N/A
Yes	Any Obstructions?	No	Yes	Storm Grate/Utility Hazard?	No
	Obstruction Type			Storm Grate/Utility Type	
		N/A			N/A
			Yes	Surface Condition? (G/P)	Good

**Remove & Replace Entire Ramp.  
Remove & Replace Gutter.**

Total Cost: \$ 2400.00
