# Access Compliance Report

## Public Rights-of-Way

### (Curb Ramps)

Intersection ID: 19146	Main Street: TYVOLA_RD	Cross Street: WEDGEWOOD_DR	Location: SW
ADA ID: 5D1F83483CA2	Ramp Type: PerpDiag	Initial Pass/Fail: Fail	Overall Compliance: No
		Severity Score: 12.5

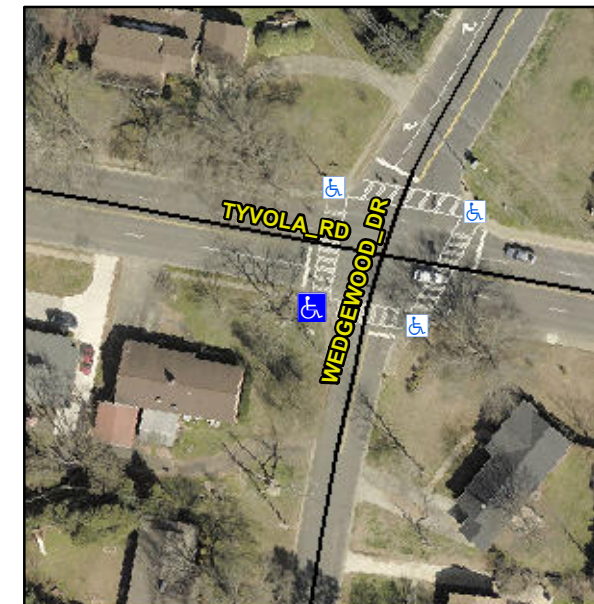
**Not Found, R304.2.2**

Compliance	Description	Data	Compliance	Description	Data
N/A	Ramp Length (in)	22.0	No	Ramp Slope (%)	9.5
Yes	Ramp Width (in)	78.0	Yes	Ramp XSlope (%)	0.3
N/A	Flare Type LT	N/A	N/A	Flare Type RT	N/A
N/A	Flare Slope LT (%)	N/A	N/A	Flare Slope RT (%)	N/A
N/A	Flare Traversable LT?	N/A	N/A	Flare Traversable RT?	N/A
N/A	Landing Length (in)	N/A	N/A	DWS Provided?	N/A
N/A	Landing Width (in)	N/A	N/A	DWS Contrast?	N/A
N/A	Landing Slope (%)	N/A	N/A	DWS Length (in)	N/A
N/A	Landing X Slope (%)	N/A	N/A	DWS Full Width?	N/A
N/A	Landing Curb? (Y/N)	N/A	N/A	DWS Offset (in)	N/A
N/A	Shared Landing?	N/A			
N/A	Gutter Ponding?	N/A	N/A	Gutter Slope (%)	N/A
N/A	Gutter Lip Ht (in)	N/A	N/A	Gutter X Slope (%)	N/A
N/A	Painted X Walk1?	Yes	N/A	Painted X Walk2?	Yes
	X Walk 1 Direction	To E		X Walk 2 Direction	To N
N/A	X Walk 1 Width (in)	104.0	N/A	X Walk 2 Width (in)	105.0
	X Walk 1 Slope (%)	3.3		X Walk 2 Slope (%)	4.8
	X Walk 1 X Slope (%)	3.3		X Walk 2 X Slope (%)	3.1

N/A	Ramp inside XWalk1?	Yes	N/A	Ramp inside XWalk2?	Yes
	Road Slope (%)	1.4	N/A	Clear Space?	N/A
	Road X Slope (%)	4.4	N/A	Clear Space to XWalk (in)	N/A
N/A	Any Obstructions?	N/A	N/A	Storm Grate/Utility Hazard?	N/A
	Obstruction Type			Storm Grate/Utility Type	
		N/A			N/A
		Yes		Surface Condition? (G/P)	Good

**Remove & Replace Curb Ramp With Two New Directional Ramps or Equivalent.**

Total Cost: \$ 3200.00
