# Access Compliance Report

## Public Rights-of-Way

### (Curb Ramps)

Intersection ID: 10485	Main Street: ANDERSON_ST	Cross Street: THE_PLAZA	Location: NW
ADA ID: 5D25083E2F84	Ramp Type: Perp	Initial Pass/Fail: Fail	Overall Compliance: No
Severity Score: 22.5			
Codes/Mitigation Info/Possible Solution		Field Measurements/Component Compliance

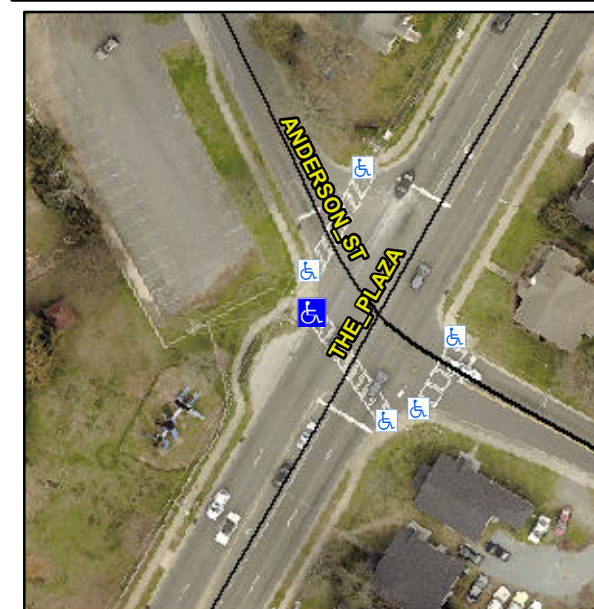
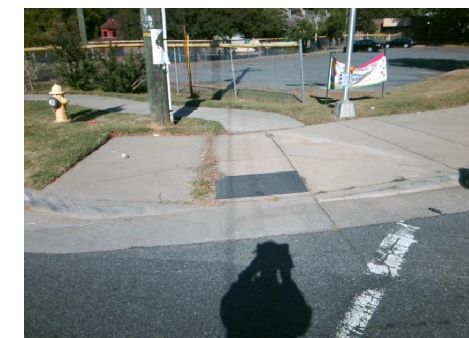
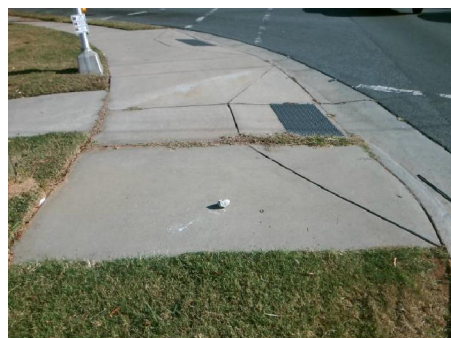
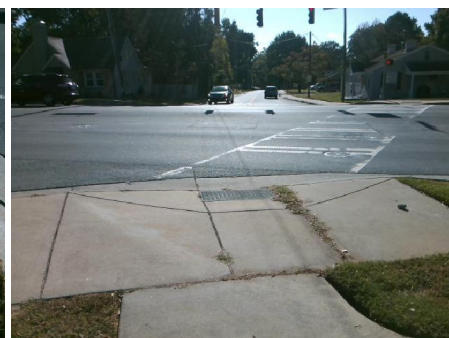
**Not Found, R304.5.1, R304.2.2**

Compliance	Description	Data	Compliance	Description	Data
N/A	Ramp Length (in)	47.5	No	Ramp Slope (%)	9.1
No	Ramp Width (in)	45.0	Yes	Ramp XSlope (%)	4.0
N/A	Flare Type LT	N/A	N/A	Flare Type RT	N/A
N/A	Flare Slope LT (%)	N/A	N/A	Flare Slope RT (%)	N/A
N/A	Flare Traversable LT?	N/A	N/A	Flare Traversable RT?	N/A
N/A	Landing Length (in)	N/A	N/A	DWS Provided?	N/A
N/A	Landing Width (in)	N/A	N/A	DWS Contrast?	N/A
N/A	Landing Slope (%)	N/A	N/A	DWS Length (in)	N/A
N/A	Landing X Slope (%)	N/A	N/A	DWS Full Width?	N/A
N/A	Landing Curb? (Y/N)	N/A	N/A	DWS Offset (in)	N/A
N/A	Shared Landing?	N/A			
N/A	Gutter Ponding?	N/A	N/A	Gutter Slope (%)	N/A
N/A	Gutter Lip Ht (in)	N/A	N/A	Gutter X Slope (%)	N/A
N/A	Painted X Walk1?	Yes	N/A	Painted X Walk2?	N/A
	X Walk 1 Direction	To SE		X Walk 2 Direction	N/A
N/A	X Walk 1 Width (in)	118.0	N/A	X Walk 2 Width (in)	N/A
	X Walk 1 Slope (%)	1.2		X Walk 2 Slope (%)	N/A
	X Walk 1 X Slope (%)	4.3		X Walk 2 X Slope (%)	N/A

N/A	Ramp inside XWalk1?	Yes	N/A	Ramp inside XWalk2?	N/A
	Road Slope (%)	N/A	N/A	Clear Space?	N/A
	Road X Slope (%)	N/A	N/A	Clear Space to XWalk (in)	N/A
N/A	Any Obstructions?	N/A	N/A	Storm Grate/Utility Hazard?	N/A
	Obstruction Type			Storm Grate/Utility Type	
		N/A			N/A
		Yes		Surface Condition? (G/P)	Good

**Remove & Replace Entire Ramp.**

Total Cost: \$ 1850.00
