Access Compliance Report

Public Rights-of-Way (Curb Ramps)

Intersection ID: 15291	Main Street: OLD_MEADOW_RD	Cross Street: SPRINGBEAUTY_DR	Location: NW
ADA ID: 5D2A1A9E4EC5	Ramp Type: PerpDiag	Initial Pass/Fail: Fail	Overall Compliance: No
		Severity Score: 12.5

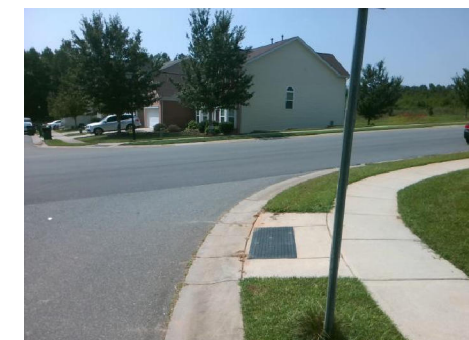
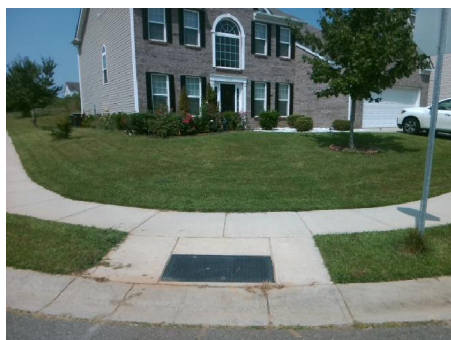
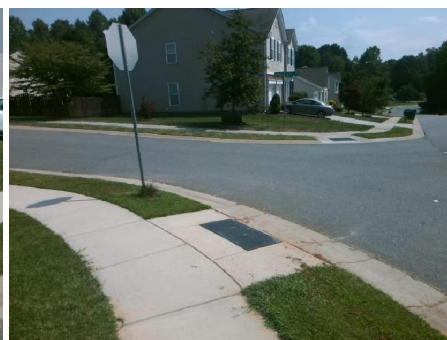
Compliance	Description	Data	Compliance	Description	Data
N/A	Ramp Length (in)	48.0	No	Ramp Slope (%)	10.9
Yes	Ramp Width (in)	48.0	Yes	Ramp XSlope (%)	0.7
N/A	Flare Type LT	N/A	N/A	Flare Type RT	N/A
N/A	Flare Slope LT (%)	N/A	N/A	Flare Slope RT (%)	N/A
N/A	Flare Traversable LT?	N/A	N/A	Flare Traversable RT?	N/A
N/A	Landing Length (in)	N/A	N/A	DWS Provided?	N/A
N/A	Landing Width (in)	N/A	N/A	DWS Contrast?	N/A
N/A	Landing Slope (%)	N/A	N/A	DWS Length (in)	N/A
N/A	Landing X Slope (%)	N/A	N/A	DWS Full Width?	N/A
N/A	Landing Curb? (Y/N)	N/A	N/A	DWS Offset (in)	N/A
N/A	Shared Landing?	N/A			
N/A	Gutter Ponding?	N/A	N/A	Gutter Slope (%)	N/A
N/A	Gutter Lip Ht (in)	N/A	N/A	Gutter X Slope (%)	N/A
N/A	Painted X Walk1?	No	N/A	Painted X Walk2?	No
	X Walk 1 Direction	To S		X Walk 2 Direction	To E
N/A	X Walk 1 Width (in)	N/A	N/A	X Walk 2 Width (in)	N/A
	X Walk 1 Slope (%)	0.1		X Walk 2 Slope (%)	1.1
	X Walk 1 X Slope (%)	0.0		X Walk 2 X Slope (%)	1.2

N/A	Ramp inside XWalk1?	N/A	N/A	Ramp inside XWalk2?	N/A
	Road Slope (%)	0.0	N/A	Clear Space?	N/A
	Road X Slope (%)	3.0	N/A	Clear Space to XWalk (in)	N/A
N/A	Any Obstructions?	N/A	N/A	Storm Grate/Utility Hazard?	N/A
	Obstruction Type			Storm Grate/Utility Type	
		N/A			N/A
			Yes	Surface Condition? (G/P)	Good

Remove & Replace Curb Ramp With Two New Directional Ramps or Equivalent.
