Access Compliance Report

Public Rights-of-Way

(Curb Ramps)

Intersection ID: 15133	Main Street: TYVOLA_RD	Cross Street: PERIMETER_POINTE_PY	Location: SW
ADA ID: 5D314DA9F529	Ramp Type: Perp	Initial Pass/Fail: Pass	Overall Compliance: No
		Severity Score: 0

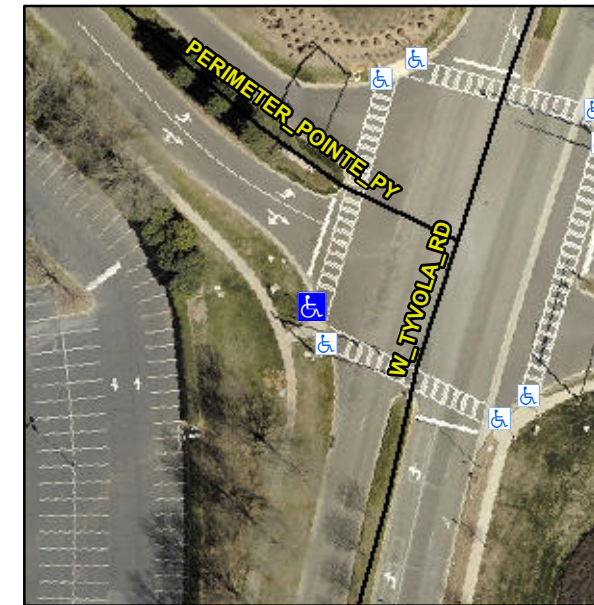
Compliance	Description	Data	Compliance	Description	Data
N/A	Ramp Length (in)	24.0	Yes	Ramp Slope (%)	8.0
Yes	Ramp Width (in)	48.0	Yes	Ramp XSlope (%)	0.7
N/A	Flare Type LT	Sloped	N/A	Flare Type RT	N/A
N/A	Flare Slope LT (%)	8.1	N/A	Flare Slope RT (%)	11.5
N/A	Flare Traversable LT?	Yes	N/A	Flare Traversable RT?	No
Yes	Landing Length (in)	55.0	Yes	DWS Provided?	Yes
No	Landing Width (in)	46.0	Yes	DWS Contrast?	Yes
Yes	Landing Slope (%)	1.2	Yes	DWS Length (in)	24.0
Yes	Landing X Slope (%)	0.0	Yes	DWS Full Width?	Yes
N/A	Landing Curb? (Y/N)	No	Yes	DWS Offset (in)	0.0
N/A	Shared Landing?	No			
Yes	Gutter Ponding?	No	Yes	Gutter Slope (%)	3.2
Yes	Gutter Lip Ht (in)	0.0	Yes	Gutter X Slope (%)	0.5
N/A	Painted X Walk1?	Yes	N/A	Painted X Walk2?	N/A
	X Walk 1 Direction	To N		X Walk 2 Direction	N/A
N/A	X Walk 1 Width (in)	102.0	N/A	X Walk 2 Width (in)	N/A
	X Walk 1 Slope (%)	3.5		X Walk 2 Slope (%)	N/A
	X Walk 1 X Slope (%)	2.8		X Walk 2 X Slope (%)	N/A

Yes	Ramp inside XWalk1?	Yes	N/A	Ramp inside XWalk2?	N/A
	Road Slope (%)	N/A	N/A	Clear Space?	Yes
	Road X Slope (%)	N/A	N/A	Clear Space to XWalk (in)	N/A
Yes	Any Obstructions?	No	Yes	Storm Grate/Utility Hazard?	No
	Obstruction Type			Storm Grate/Utility Type	
		N/A			N/A
			Yes	Surface Condition? (G/P)	Good

Possible Solutions:

Remove & Replace Landing.

PROW/ADA:

R304.2.1
