Access Compliance Report Public Rights-of-Way (Curb Ramps)

Intersection ID: 49659 Main Street: GREEN TRAIL LN **Cross Street: WINDING PATH WY** Location: S **Overall Compliance: No Severity Score:** 0 ADA ID: 5D3189738D25 Ramp Type: Perp Initial Pass/Fail: Pass

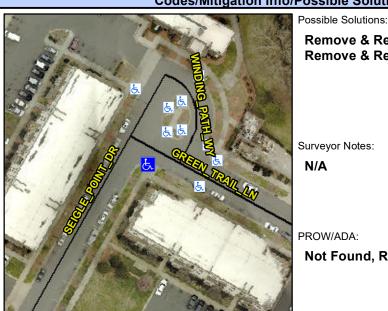
GREEN TRAIL LN Street 1 Name Stop Condition-Street 2 StopSign N/A Street 2 Name Stop Condition-Street 1 N/A

Remove & Replace Entire Ramp. Remove & Replace Gutter. Surveyor Notes: N/A PROW/ADA: Not Found, R304.5.3, R305.2, R302.7
