Access Compliance Report

Public Rights-of-Way

(Curb Ramps)

Intersection ID: 24562	Main Street: CAVAN_CT	Cross Street: SWINFORD_PL	Location: NE
ADA ID: 5D3454308E13	Ramp Type: Perp	Initial Pass/Fail: Fail	Overall Compliance: No
Severity Score: 8.75			
Codes/Mitigation Info/Possible Solution		Field Measurements/Component Compliance

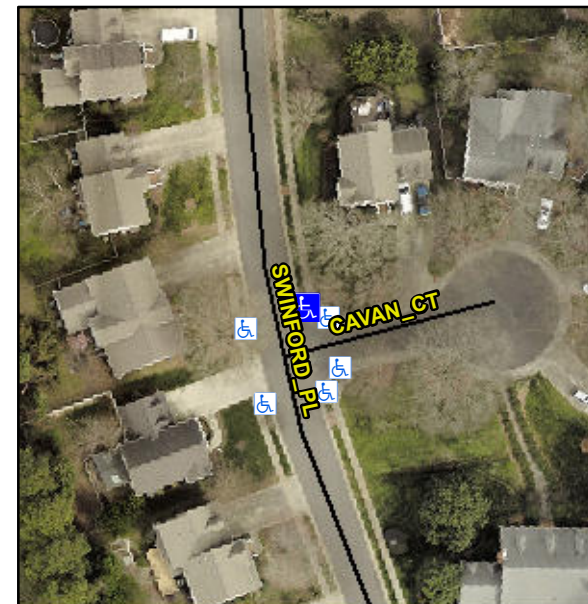
Not Found, R304.5.1

Compliance	Description	Data	Compliance	Description	Data
N/A	Ramp Length (in)	48.0	Yes	Ramp Slope (%)	6.7
No	Ramp Width (in)	36.0	Yes	Ramp XSlope (%)	1.2
N/A	Flare Type LT	N/A	N/A	Flare Type RT	N/A
N/A	Flare Slope LT (%)	N/A	N/A	Flare Slope RT (%)	N/A
N/A	Flare Traversable LT?	N/A	N/A	Flare Traversable RT?	N/A
N/A	Landing Length (in)	N/A	N/A	DWS Provided?	N/A
N/A	Landing Width (in)	N/A	N/A	DWS Contrast?	N/A
N/A	Landing Slope (%)	N/A	N/A	DWS Length (in)	N/A
N/A	Landing X Slope (%)	N/A	N/A	DWS Full Width?	N/A
N/A	Landing Curb? (Y/N)	N/A	N/A	DWS Offset (in)	N/A
N/A	Shared Landing?	N/A			
N/A	Gutter Ponding?	N/A	N/A	Gutter Slope (%)	N/A
N/A	Gutter Lip Ht (in)	N/A	N/A	Gutter X Slope (%)	N/A
N/A	Painted X Walk1?	No	N/A	Painted X Walk2?	N/A
	X Walk 1 Direction	To W		X Walk 2 Direction	N/A
N/A	X Walk 1 Width (in)	N/A	N/A	X Walk 2 Width (in)	N/A
	X Walk 1 Slope (%)	2.9		X Walk 2 Slope (%)	N/A
	X Walk 1 X Slope (%)	0.9		X Walk 2 X Slope (%)	N/A

N/A	Ramp inside XWalk1?	N/A	N/A	Ramp inside XWalk2?	N/A
	Road Slope (%)	N/A	N/A	Clear Space?	N/A
	Road X Slope (%)	N/A	N/A	Clear Space to XWalk (in)	N/A
N/A	Any Obstructions?	N/A	N/A	Storm Grate/Utility Hazard?	N/A
	Obstruction Type			Storm Grate/Utility Type	
		N/A			N/A
			Yes	Surface Condition? (G/P)	Good

Remove & Replace Entire Ramp.

Total Cost: \$ 1850.00
