# Access Compliance Report

## Public Rights-of-Way (Curb Ramps)

Intersection ID: N/A	Main Street: CRESSWIND BV	Cross Street: SILVER SPRINGS CT	Location: NW
ADA ID: 5D36184809F6	Ramp Type: Perp	Initial Pass/Fail: Fail	Overall Compliance: No
			Severity Score: 26.25

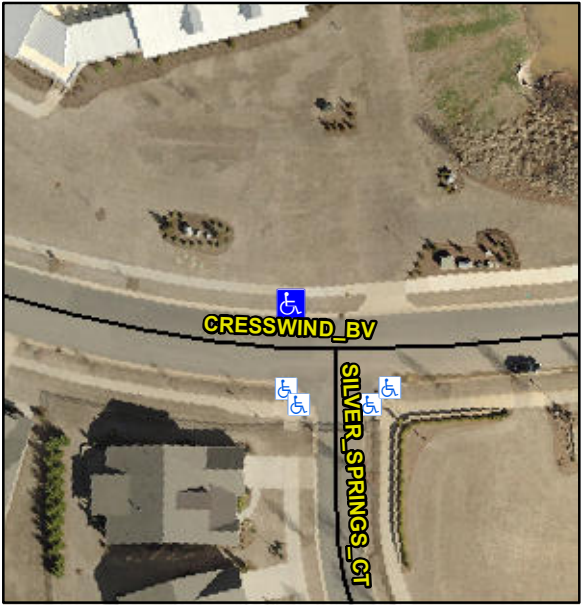
Possible Solutions:		<b>Compliance</b>	<b>Description</b>	<b>Data</b>
	<b>Remove &amp; Replace Entire Ramp.</b>		<b>No</b>	Ramp Length (in)	<b>97.0</b>
			<b>Yes</b>	Ramp Width (in)	<b>92.0</b>
			<b>N/A</b>	Flare Type LT	<b>N/A</b>
			<b>N/A</b>	Flare Slope LT (%)	<b>N/A</b>
			<b>N/A</b>	Flare Traversable LT?	<b>No</b>
			<b>N/A</b>	Landing Length (in)	<b>N/A</b>
			<b>N/A</b>	Landing Width (in)	<b>N/A</b>
			<b>N/A</b>	Landing Slope (%)	<b>N/A</b>
			<b>N/A</b>	Landing X Slope (%)	<b>N/A</b>
<p>Surveyor Notes:</p> <p><b>N/A</b></p>			<b>N/A</b>	Landing Curb? (Y/N)	<b>N/A</b>
			<b>N/A</b>	Shared Landing?	<b>N/A</b>
			<b>N/A</b>	Gutter Ponding?	<b>N/A</b>
			<b>N/A</b>	Gutter Lip Ht (in)	<b>1.5</b>
			<b>N/A</b>	Painted X Walk1?	<b>No</b>
				X Walk 1 Direction	<b>To S</b>
			<b>N/A</b>	X Walk 1 Width (in)	<b>N/A</b>

X Walk 1 Slope (%)	<b>2.2</b>
				X Walk 1 X Slope (%)	<b>2.2</b>
			<b>N/A</b>	Ramp inside XWalk1?	<b>N/A</b>
<p>PROW/ADA:</p> <p><b>Not Found, R304.2.2, R304.5.3</b></p>			<b>N/A</b>	Road Slope (%)	<b>N/A</b>
			<b>N/A</b>	Road X Slope (%)	<b>N/A</b>
			<b>N/A</b>	Any Obstructions?	<b>N/A</b>
				Obstruction Type	
			<b>N/A</b>		
			<b>N/A</b>		
			<b>N/A</b>		
			<b>N/A</b>		
			<b>N/A</b>		
			<b>N/A</b>		
<p>Street 1 Name</p> <p>Stop Condition-Street 2</p> <p>Street 2 Name</p> <p>Stop Condition-Street 1</p>			<b>N/A</b>	Storm Grate/Utility Hazard?	<b>N/A</b>
				Storm Grate/Utility Type	
			<b>N/A</b>		
			<b>N/A</b>		
			<b>N/A</b>		
			<b>N/A</b>		
			<b>N/A</b>		
			<b>N/A</b>		
			<b>N/A</b>		
			<b>N/A</b>		
<p>Total Cost:</p> <p><b>\$ 1850.00</b></p>			<b>Yes</b>	Surface Condition? (G/P)	<b>Good</b>
