Access Compliance Report

Public Rights-of-Way

(Curb Ramps)

Intersection ID: 29339	Main Street: NEVIN_BROOK_RD	Cross Street: NEVIN_RD	Location: SW
ADA ID: 5D42D4ECD0B1	Ramp Type: Perp	Initial Pass/Fail: Fail	Overall Compliance: No
Severity Score: 10			
Codes/Mitigation Info/Possible Solution		Field Measurements/Component Compliance

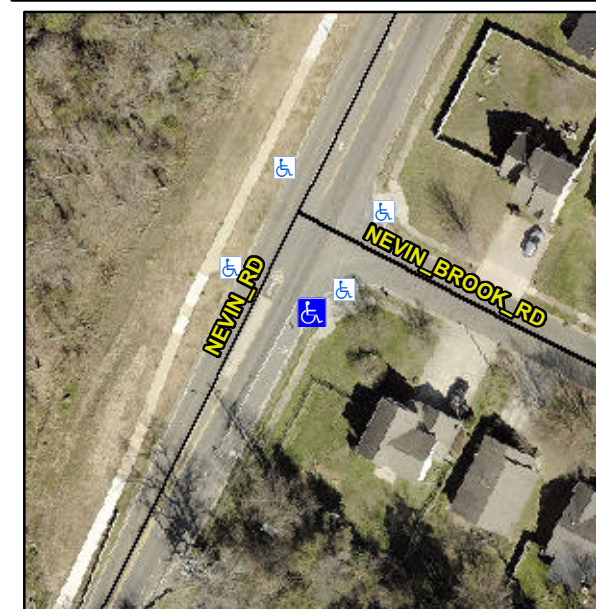
Not Found, R304.5.1

Compliance	Description	Data	Compliance	Description	Data
N/A	Ramp Length (in)	75.5	Yes	Ramp Slope (%)	6.2
No	Ramp Width (in)	44.5	Yes	Ramp XSlope (%)	2.6
N/A	Flare Type LT	N/A	N/A	Flare Type RT	N/A
N/A	Flare Slope LT (%)	N/A	N/A	Flare Slope RT (%)	N/A
N/A	Flare Traversable LT?	N/A	N/A	Flare Traversable RT?	N/A
N/A	Landing Length (in)	N/A	N/A	DWS Provided?	N/A
N/A	Landing Width (in)	N/A	N/A	DWS Contrast?	N/A
N/A	Landing Slope (%)	N/A	N/A	DWS Length (in)	N/A
N/A	Landing X Slope (%)	N/A	N/A	DWS Full Width?	N/A
N/A	Landing Curb? (Y/N)	N/A	N/A	DWS Offset (in)	N/A
N/A	Shared Landing?	N/A			
N/A	Gutter Ponding?	N/A	N/A	Gutter Slope (%)	N/A
N/A	Gutter Lip Ht (in)	N/A	N/A	Gutter X Slope (%)	N/A
N/A	Painted X Walk1?	No	N/A	Painted X Walk2?	N/A
	X Walk 1 Direction	To NW		X Walk 2 Direction	N/A
N/A	X Walk 1 Width (in)	N/A	N/A	X Walk 2 Width (in)	N/A
	X Walk 1 Slope (%)	5.9		X Walk 2 Slope (%)	N/A
	X Walk 1 X Slope (%)	4.2		X Walk 2 X Slope (%)	N/A

N/A	Ramp inside XWalk1?	N/A	N/A	Ramp inside XWalk2?	N/A
	Road Slope (%)	N/A	N/A	Clear Space?	N/A
	Road X Slope (%)	N/A	N/A	Clear Space to XWalk (in)	N/A
N/A	Any Obstructions?	N/A	N/A	Storm Grate/Utility Hazard?	N/A
	Obstruction Type			Storm Grate/Utility Type	
		N/A			N/A
			Yes	Surface Condition? (G/P)	Good

Remove & Replace Entire Ramp.

Total Cost: \$ 1850.00
