Access Compliance Report

Public Rights-of-Way

(Curb Ramps)

Intersection ID: 15869	Main Street: MARSH_RD	Cross Street: SEDGEFIELD_RD	Location: E
ADA ID: 5D4896843FF3	Ramp Type: PerpDiag	Initial Pass/Fail: Fail	Overall Compliance: No
Severity Score: 12.5			
Codes/Mitigation Info/Possible Solution		Field Measurements/Component Compliance

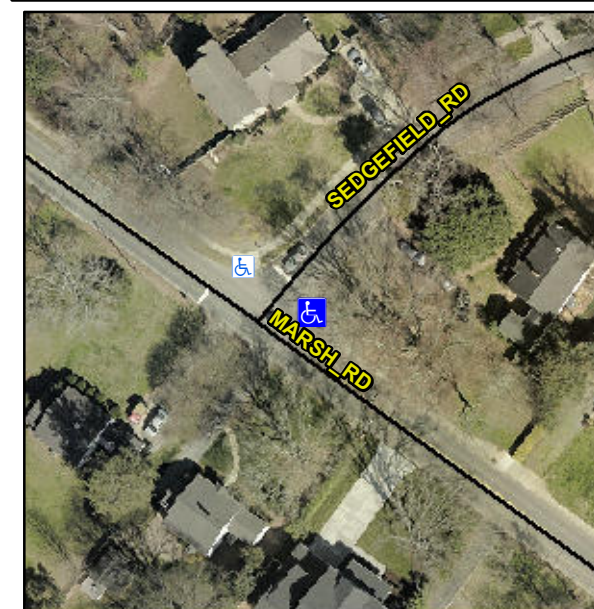
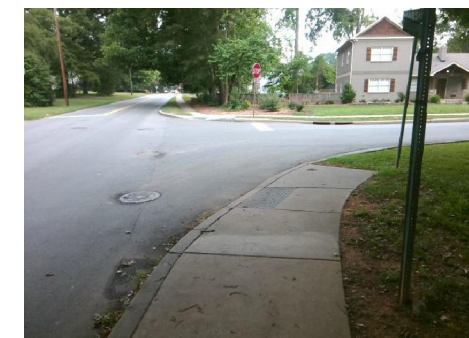
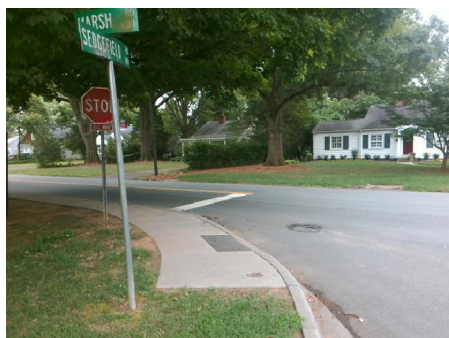
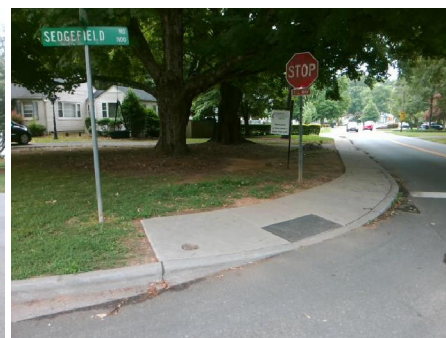
PROW/ADA:

Not Found, R304.2.2

Compliance	Description	Data	Compliance	Description	Data
N/A	Ramp Length (in)	61.0	No	Ramp Slope (%)	9.0
Yes	Ramp Width (in)	48.0	Yes	Ramp XSlope (%)	1.5
N/A	Flare Type LT	N/A	N/A	Flare Type RT	N/A
N/A	Flare Slope LT (%)	N/A	N/A	Flare Slope RT (%)	N/A
N/A	Flare Traversable LT?	N/A	N/A	Flare Traversable RT?	N/A
N/A	Landing Length (in)	N/A	N/A	DWS Provided?	N/A
N/A	Landing Width (in)	N/A	N/A	DWS Contrast?	N/A
N/A	Landing Slope (%)	N/A	N/A	DWS Length (in)	N/A
N/A	Landing X Slope (%)	N/A	N/A	DWS Full Width?	N/A
N/A	Landing Curb? (Y/N)	N/A	N/A	DWS Offset (in)	N/A
N/A	Shared Landing?	N/A			
N/A	Gutter Ponding?	N/A	N/A	Gutter Slope (%)	N/A
N/A	Gutter Lip Ht (in)	N/A	N/A	Gutter X Slope (%)	N/A
N/A	Painted X Walk1?	No	N/A	Painted X Walk2?	No
	X Walk 1 Direction	To NW		X Walk 2 Direction	To SW
N/A	X Walk 1 Width (in)	N/A	N/A	X Walk 2 Width (in)	N/A
	X Walk 1 Slope (%)	0.6		X Walk 2 Slope (%)	0.9
	X Walk 1 X Slope (%)	2.1		X Walk 2 X Slope (%)	0.8

N/A	Ramp inside XWalk1?	N/A	N/A	Ramp inside XWalk2?	N/A
	Road Slope (%)	1.4	N/A	Clear Space?	N/A
	Road X Slope (%)	1.0	N/A	Clear Space to XWalk (in)	N/A
N/A	Any Obstructions?	N/A	N/A	Storm Grate/Utility Hazard?	N/A
	Obstruction Type			Storm Grate/Utility Type	
		N/A			N/A
		Yes		Surface Condition? (G/P)	Good

Possible Solutions:

Remove & Replace Curb Ramp With Two New Directional Ramps or Equivalent.
