# Access Compliance Report

## Public Rights-of-Way

| Intersection ID: 15105 | Main Street: N_DOTGER_AV | Cross Street: RANDOLPH_RD | Location: N |
| ADA ID: 5D4D73E9DE44 | Ramp Type: PerpDiag | Initial Pass/Fail: Pass | Overall Compliance: No |

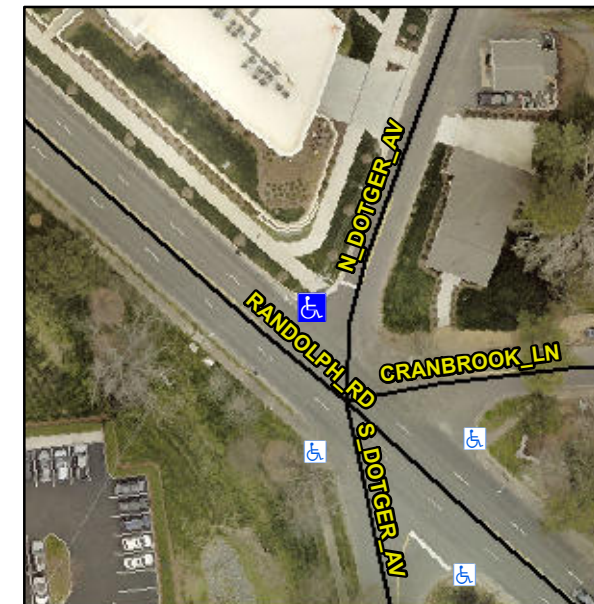
| | | | Severity Score: 22.75 |

**Not Found, R304.5.3, R304.2.1, R304.2.2-Perp, R304.3.2-Para, R304.2.3, R305**

| Compliance | Description | Data | Compliance | Description | Data |
|---|---|---|---|---|---|
| Yes | Ramp Width (in) | 62.0 | No | Ramp XSlope (%) | 3.8 |
| N/A | Flare Slope LT (%) | 5.0 | No | Flare Slope RT (%) | 11.4 |
| No | Landing Length (in) | N/A | No | DWS Provided? | No |
| Yes | Gutter Lip Ht (in) | 0.0 | No | Gutter X Slope (%) | 7.5 |

**Remove & Replace Curb Ramp With Two New Directional Ramps or Equivalent. Remove & Replace Gutter.**

Total Cost: \$ 3950.00
