Access Compliance Report

Public Rights-of-Way

(Curb Ramps)

Intersection ID: 7399	Main Street: B_AV	Cross Street: BEATTIES_FORD_RD	Location: SE
ADA ID: 5D4DACC613DD	Ramp Type: Perp	Initial Pass/Fail: Fail	Overall Compliance: No
Severity Score: 22.5			
Codes/Mitigation Info/Possible Solution		Field Measurements/Component Compliance

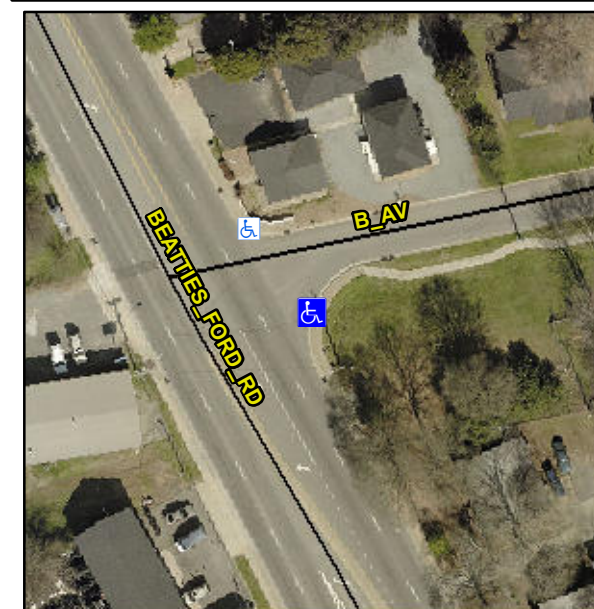
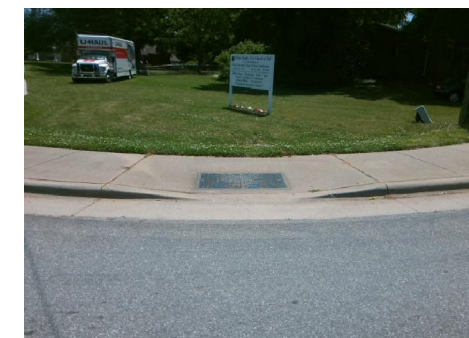
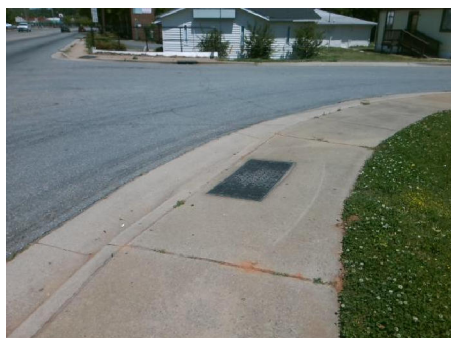
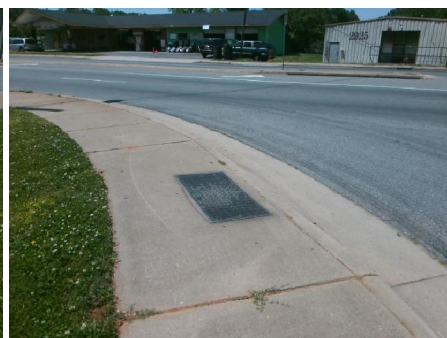
Not Found, R304.5.1, R304.2.2, R304.5.3

Compliance	Description	Data	Compliance	Description	Data
N/A	Ramp Length (in)	60.0	No	Ramp Slope (%)	10.4
No	Ramp Width (in)	45.0	No	Ramp XSlope (%)	3.7
N/A	Flare Type LT	N/A	N/A	Flare Type RT	N/A
N/A	Flare Slope LT (%)	N/A	N/A	Flare Slope RT (%)	N/A
N/A	Flare Traversable LT?	N/A	N/A	Flare Traversable RT?	N/A
N/A	Landing Length (in)	N/A	N/A	DWS Provided?	N/A
N/A	Landing Width (in)	N/A	N/A	DWS Contrast?	N/A
N/A	Landing Slope (%)	N/A	N/A	DWS Length (in)	N/A
N/A	Landing X Slope (%)	N/A	N/A	DWS Full Width?	N/A
N/A	Landing Curb? (Y/N)	N/A	N/A	DWS Offset (in)	N/A
N/A	Shared Landing?	N/A			
N/A	Gutter Ponding?	N/A	N/A	Gutter Slope (%)	N/A
N/A	Gutter Lip Ht (in)	N/A	N/A	Gutter X Slope (%)	N/A
N/A	Painted X Walk1?	No	N/A	Painted X Walk2?	N/A
	X Walk 1 Direction	To NW		X Walk 2 Direction	N/A
N/A	X Walk 1 Width (in)	N/A	N/A	X Walk 2 Width (in)	N/A
	X Walk 1 Slope (%)	1.6		X Walk 2 Slope (%)	N/A
	X Walk 1 X Slope (%)	1.7		X Walk 2 X Slope (%)	N/A

N/A	Ramp inside XWalk1?	N/A	N/A	Ramp inside XWalk2?	N/A
	Road Slope (%)	N/A	N/A	Clear Space?	N/A
	Road X Slope (%)	N/A	N/A	Clear Space to XWalk (in)	N/A
N/A	Any Obstructions?	N/A	N/A	Storm Grate/Utility Hazard?	N/A
	Obstruction Type			Storm Grate/Utility Type	
		N/A			N/A
			Yes	Surface Condition? (G/P)	Good

Remove & Replace Entire Ramp.
