Access Compliance Report

Public Rights-of-Way

(Curb Ramps)

Intersection ID: 10031554	Main Street: MEACHAM_ST	Cross Street: N/A	Location: SW
ADA ID: 5D5879B8424F	Ramp Type: Directional	Initial Pass/Fail: Fail	Overall Compliance: No
		Severity Score: 10

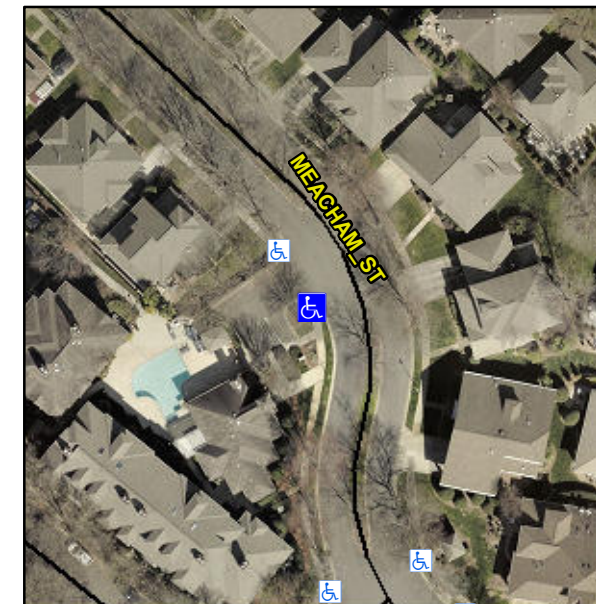
Compliance	Description	Data	Compliance	Description	Data
N/A	Ramp Length (in)	49.0	N/A	Grade Break?	N/A
No	Ramp Width (in)	39.0	N/A	Grade Break Slope (%)	0.0
Yes	Ramp Slope (%)	1.2	N/A	Grade Break XSlope (%)	0.0
No	Ramp XSlope (%)	2.9			
N/A	Flare Type LT	N/A	N/A	Flare Type RT	N/A
N/A	Flare Slope LT (%)	N/A	N/A	Flare Slope RT (%)	0.0
N/A	Flare Traversable LT?	N/A	N/A	Flare Traversable RT?	N/A
N/A	Landing Length (in)	0.0	N/A	DWS Provided?	N/A
N/A	Landing Width (in)	0.0	N/A	DWS Contrast?	N/A
N/A	Landing Slope (%)	0.0	N/A	DWS Length (in)	N/A
N/A	Landing X Slope (%)	0.0	N/A	DWS Full Width?	N/A
N/A	Landing Curb? (Y/N)	N/A	N/A	DWS Offset LT (in)	N/A
N/A	Shared Landing?	N/A	N/A	DWS Offset RT (in)	N/A
N/A	Gutter Ponding?	0.0	N/A	Gutter Slope (%)	N/A
N/A	Gutter Lip Ht (in)	0.0	N/A	Gutter X Slope (%)	N/A
N/A	Painted X Walk1?	No		Road Slope (%)	0.6
	X Walk 1 Direction	To NW		Road X Slope (%)	0.6
	X Walk 1 Width (in)	N/A		Clear Space?	N/A

X Walk 1 Slope (%)	0.6	N/A	Clear Space to XWalk (in)	N/A
	X Walk 1 X Slope (%)	0.6	N/A	Storm Grate/Utility Hazard?	N/A
N/A	Ramp inside XWalk1?	N/A		Storm Grate/Utility Type	
N/A	Any Obstructions?	N/A			N/A
	Obstruction Type		Yes	Surface Condition? (G/P)	Good
			N/A	Curb Slope (%)	2.4

Remove & Replace Entire Ramp.
