Access Compliance Report

Public Rights-of-Way

(Curb Ramps)

Intersection ID: 43869	Main Street: CALDWELL_RIDGE_PY	Cross Street: SIDNEY_CREST_AV	Location: NE
ADA ID: 5D66FF095B62	Ramp Type: Perp	Initial Pass/Fail: Fail	Overall Compliance: No
Severity Score: 33.75			
Codes/Mitigation Info/Possible Solution		Field Measurements/Component Compliance

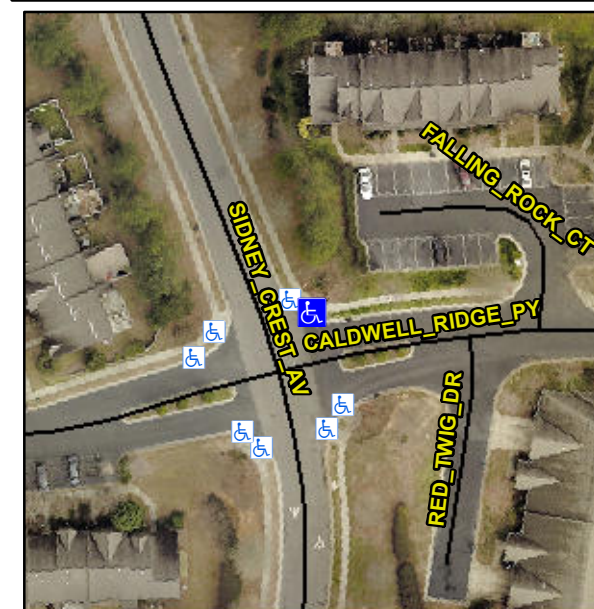
Not Found, R304.5.1, R304.5.3

Compliance	Description	Data	Compliance	Description	Data
N/A	Ramp Length (in)	46.5	Yes	Ramp Slope (%)	6.1
No	Ramp Width (in)	41.5	No	Ramp XSlope (%)	10.0
N/A	Flare Type LT	N/A	N/A	Flare Type RT	N/A
N/A	Flare Slope LT (%)	N/A	N/A	Flare Slope RT (%)	N/A
N/A	Flare Traversable LT?	N/A	N/A	Flare Traversable RT?	N/A
N/A	Landing Length (in)	N/A	N/A	DWS Provided?	N/A
N/A	Landing Width (in)	N/A	N/A	DWS Contrast?	N/A
N/A	Landing Slope (%)	N/A	N/A	DWS Length (in)	N/A
N/A	Landing X Slope (%)	N/A	N/A	DWS Full Width?	N/A
N/A	Landing Curb? (Y/N)	N/A	N/A	DWS Offset (in)	N/A
N/A	Shared Landing?	N/A			
N/A	Gutter Ponding?	N/A	N/A	Gutter Slope (%)	N/A
N/A	Gutter Lip Ht (in)	N/A	N/A	Gutter X Slope (%)	N/A
N/A	Painted X Walk1?	No	N/A	Painted X Walk2?	N/A
	X Walk 1 Direction	To S		X Walk 2 Direction	N/A
N/A	X Walk 1 Width (in)	N/A	N/A	X Walk 2 Width (in)	N/A
	X Walk 1 Slope (%)	6.1		X Walk 2 Slope (%)	N/A
	X Walk 1 X Slope (%)	2.2		X Walk 2 X Slope (%)	N/A

N/A	Ramp inside XWalk1?	N/A	N/A	Ramp inside XWalk2?	N/A
	Road Slope (%)	N/A	N/A	Clear Space?	N/A
	Road X Slope (%)	N/A	N/A	Clear Space to XWalk (in)	N/A
N/A	Any Obstructions?	N/A	N/A	Storm Grate/Utility Hazard?	N/A
	Obstruction Type			Storm Grate/Utility Type	
		N/A			N/A
			Yes	Surface Condition? (G/P)	Good

Possible Solutions:

Remove & Replace Entire Ramp.
