Access Compliance Report

Public Rights-of-Way

(Curb Ramps)

Intersection ID: 13829	Main Street: E_MOREHEAD_ST	Cross Street: DILWORTH_RD	Location: W
ADA ID: 5D6C965CBE95	Ramp Type: Perp	Initial Pass/Fail: Fail	Overall Compliance: No
Codes/Mitigation Info/Possible Solution		Field Measurements/Component Compliance

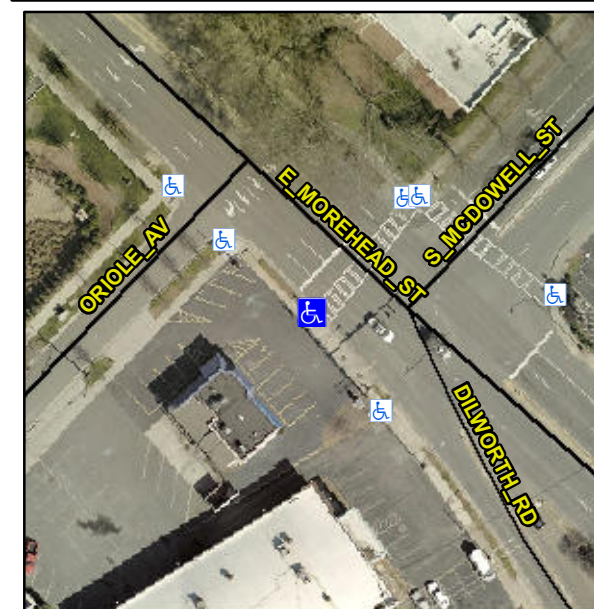
Not Found, R304.2.2, R304.5.3

Compliance	Description	Data	Compliance	Description	Data
N/A	Ramp Length (in)	89.0	No	Ramp Slope (%)	9.6
Yes	Ramp Width (in)	48.0	No	Ramp XSlope (%)	2.7
N/A	Flare Type LT	N/A	N/A	Flare Type RT	N/A
N/A	Flare Slope LT (%)	N/A	N/A	Flare Slope RT (%)	N/A
N/A	Flare Traversable LT?	N/A	N/A	Flare Traversable RT?	N/A
N/A	Landing Length (in)	N/A	N/A	DWS Provided?	N/A
N/A	Landing Width (in)	N/A	N/A	DWS Contrast?	N/A
N/A	Landing Slope (%)	N/A	N/A	DWS Length (in)	N/A
N/A	Landing X Slope (%)	N/A	N/A	DWS Full Width?	N/A
N/A	Landing Curb? (Y/N)	N/A	N/A	DWS Offset (in)	N/A
N/A	Shared Landing?	N/A			
N/A	Gutter Ponding?	N/A	N/A	Gutter Slope (%)	N/A
N/A	Gutter Lip Ht (in)	N/A	N/A	Gutter X Slope (%)	N/A
N/A	Painted X Walk1?	Yes	N/A	Painted X Walk2?	N/A
	X Walk 1 Direction	To NE		X Walk 2 Direction	N/A
N/A	X Walk 1 Width (in)	114.0	N/A	X Walk 2 Width (in)	N/A
	X Walk 1 Slope (%)	2.2		X Walk 2 Slope (%)	N/A
	X Walk 1 X Slope (%)	2.3		X Walk 2 X Slope (%)	N/A

N/A	Ramp inside XWalk1?	Yes	N/A	Ramp inside XWalk2?	N/A
	Road Slope (%)	N/A	N/A	Clear Space?	N/A
	Road X Slope (%)	N/A	N/A	Clear Space to XWalk (in)	N/A
N/A	Any Obstructions?	N/A	N/A	Storm Grate/Utility Hazard?	N/A
	Obstruction Type			Storm Grate/Utility Type	
		N/A			N/A
			Yes	Surface Condition? (G/P)	Good

Remove & Replace Entire Ramp.
