Access Compliance Report

Public Rights-of-Way

(Curb Ramps)

Intersection ID: 10037245	Main Street: SARDIS_CROSSING_DR	Cross Street: N/A	Location: NE
ADA ID: 5D6EF826548B	Ramp Type: Perp	Initial Pass/Fail: Fail	Overall Compliance: No
Severity Score: 48.75			
Codes/Mitigation Info/Possible Solution		Field Measurements/Component Compliance

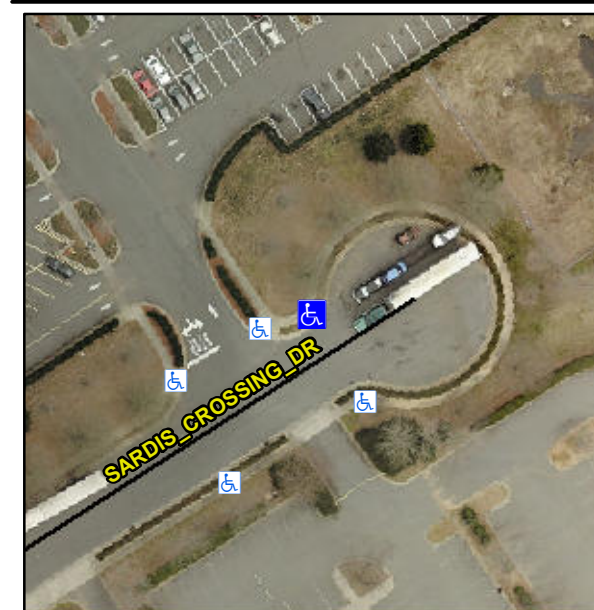
Compliance	Description	Data	Compliance	Description	Data
N/A	Ramp Length (in)	48.0	No	Ramp Slope (%)	10.2
No	Ramp Width (in)	27.0	No	Ramp XSlope (%)	4.3
N/A	Flare Type LT	N/A	N/A	Flare Type RT	N/A
N/A	Flare Slope LT (%)	N/A	N/A	Flare Slope RT (%)	N/A
N/A	Flare Traversable LT?	N/A	N/A	Flare Traversable RT?	N/A
N/A	Landing Length (in)	N/A	N/A	DWS Provided?	N/A
N/A	Landing Width (in)	N/A	N/A	DWS Contrast?	N/A
N/A	Landing Slope (%)	N/A	N/A	DWS Length (in)	N/A
N/A	Landing X Slope (%)	N/A	N/A	DWS Full Width?	N/A
N/A	Landing Curb? (Y/N)	N/A	N/A	DWS Offset (in)	N/A
N/A	Shared Landing?	N/A			
N/A	Gutter Ponding?	N/A	N/A	Gutter Slope (%)	N/A
N/A	Gutter Lip Ht (in)	N/A	N/A	Gutter X Slope (%)	N/A
N/A	Painted X Walk1?	No	N/A	Painted X Walk2?	N/A
	X Walk 1 Direction	To S		X Walk 2 Direction	N/A
N/A	X Walk 1 Width (in)	N/A	N/A	X Walk 2 Width (in)	N/A
	X Walk 1 Slope (%)	4.4		X Walk 2 Slope (%)	N/A
	X Walk 1 X Slope (%)	0.9		X Walk 2 X Slope (%)	N/A

N/A	Ramp inside XWalk1?	N/A	N/A	Ramp inside XWalk2?	N/A
	Road Slope (%)	N/A	N/A	Clear Space?	N/A
	Road X Slope (%)	N/A	N/A	Clear Space to XWalk (in)	N/A
N/A	Any Obstructions?	N/A	N/A	Storm Grate/Utility Hazard?	N/A
	Obstruction Type			Storm Grate/Utility Type	
		N/A			N/A
			Yes	Surface Condition? (G/P)	Good

Possible Solutions:

Remove & Replace Entire Ramp.

R304.5.1, R304.2.2, R304.5.3
