Access Compliance Report

Public Rights-of-Way

(Curb Ramps)

Intersection ID: 31816	Main Street: SEDGEWOOD_CR	Cross Street: SEDGEWOOD_FOREST_LN	Location: NE
ADA ID: 5D7C466E958B	Ramp Type: PerpDiag	Initial Pass/Fail: Fail	Overall Compliance: No
Severity Score: 8.75			
Codes/Mitigation Info/Possible Solution		Field Measurements/Component Compliance

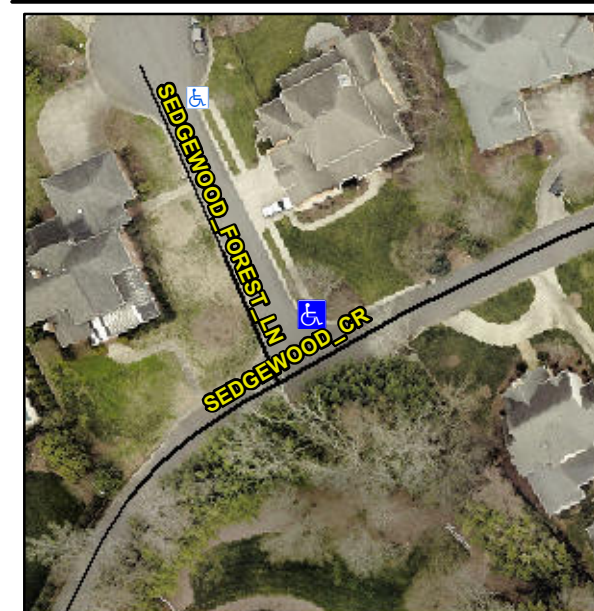
Compliance	Description	Data	Compliance	Description	Data
N/A	Ramp Length (in)	47.0	Yes	Ramp Slope (%)	5.3
No	Ramp Width (in)	42.0	Yes	Ramp XSlope (%)	0.7
N/A	Flare Type LT	N/A	N/A	Flare Type RT	N/A
N/A	Flare Slope LT (%)	N/A	N/A	Flare Slope RT (%)	N/A
N/A	Flare Traversable LT?	N/A	N/A	Flare Traversable RT?	N/A
N/A	Landing Length (in)	N/A	N/A	DWS Provided?	N/A
N/A	Landing Width (in)	N/A	N/A	DWS Contrast?	N/A
N/A	Landing Slope (%)	N/A	N/A	DWS Length (in)	N/A
N/A	Landing X Slope (%)	N/A	N/A	DWS Full Width?	N/A
N/A	Landing Curb? (Y/N)	N/A	N/A	DWS Offset (in)	N/A
N/A	Shared Landing?	N/A			
N/A	Gutter Ponding?	N/A	N/A	Gutter Slope (%)	N/A
N/A	Gutter Lip Ht (in)	N/A	N/A	Gutter X Slope (%)	N/A
N/A	Painted X Walk1?	No	N/A	Painted X Walk2?	No
	X Walk 1 Direction	To SW		X Walk 2 Direction	To SE
N/A	X Walk 1 Width (in)	N/A	N/A	X Walk 2 Width (in)	N/A
	X Walk 1 Slope (%)	3.1		X Walk 2 Slope (%)	2.7
	X Walk 1 X Slope (%)	6.1		X Walk 2 X Slope (%)	4.9

N/A	Ramp inside XWalk1?	N/A	N/A	Ramp inside XWalk2?	N/A
	Road Slope (%)	0.6	N/A	Clear Space?	N/A
	Road X Slope (%)	6.9	N/A	Clear Space to XWalk (in)	N/A
N/A	Any Obstructions?	N/A	N/A	Storm Grate/Utility Hazard?	N/A
	Obstruction Type			Storm Grate/Utility Type	
		N/A			N/A
			Yes	Surface Condition? (G/P)	Good

Possible Solutions:

Remove & Replace Curb Ramp With Two New Directional Ramps or Equivalent.

R304.5.1

Total Cost: \$ 3200.00
