# Access Compliance Report

## Public Rights-of-Way

### (Curb Ramps)

Intersection ID: 10023986	Main Street: COPPER_WY	Cross Street: N/A	Location: W
ADA ID: 5D821593179F	Ramp Type: Perp	Initial Pass/Fail: Fail	Overall Compliance: No
		Severity Score: 25

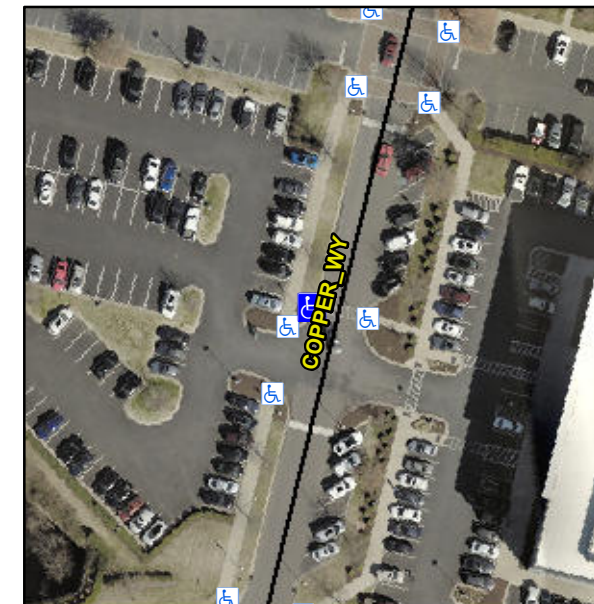
Compliance	Description	Data	Compliance	Description	Data
N/A	Ramp Length (in)	99.0	No	Ramp Slope (%)	14.0
Yes	Ramp Width (in)	48.0	Yes	Ramp XSlope (%)	1.7
N/A	Flare Type LT	N/A	N/A	Flare Type RT	N/A
N/A	Flare Slope LT (%)	N/A	N/A	Flare Slope RT (%)	N/A
N/A	Flare Traversable LT?	N/A	N/A	Flare Traversable RT?	N/A
N/A	Landing Length (in)	N/A	N/A	DWS Provided?	N/A
N/A	Landing Width (in)	N/A	N/A	DWS Contrast?	N/A
N/A	Landing Slope (%)	N/A	N/A	DWS Length (in)	N/A
N/A	Landing X Slope (%)	N/A	N/A	DWS Full Width?	N/A
N/A	Landing Curb? (Y/N)	N/A	N/A	DWS Offset (in)	N/A
N/A	Shared Landing?	N/A			
N/A	Gutter Ponding?	N/A	N/A	Gutter Slope (%)	N/A
N/A	Gutter Lip Ht (in)	N/A	N/A	Gutter X Slope (%)	N/A
N/A	Painted X Walk1?	Yes	N/A	Painted X Walk2?	N/A
	X Walk 1 Direction	To E		X Walk 2 Direction	N/A
N/A	X Walk 1 Width (in)	55.5	N/A	X Walk 2 Width (in)	N/A
	X Walk 1 Slope (%)	1.2		X Walk 2 Slope (%)	N/A
	X Walk 1 X Slope (%)	0.2		X Walk 2 X Slope (%)	N/A

N/A	Ramp inside XWalk1?	Yes	N/A	Ramp inside XWalk2?	N/A
	Road Slope (%)	N/A	N/A	Clear Space?	N/A
	Road X Slope (%)	N/A	N/A	Clear Space to XWalk (in)	N/A
N/A	Any Obstructions?	N/A	N/A	Storm Grate/Utility Hazard?	N/A
	Obstruction Type			Storm Grate/Utility Type	
		N/A			N/A
		Yes		Surface Condition? (G/P)	Good

Possible Solutions:

**Remove & Replace Entire Ramp.**

PROW/ADA:

**R304.2.2**
