Access Compliance Report

Public Rights-of-Way

(Curb Ramps)

| Intersection ID: 52906 | Main Street: JOHNSTON_RD | Cross Street: CLEMS_CROSSING_DR | Location: SE |

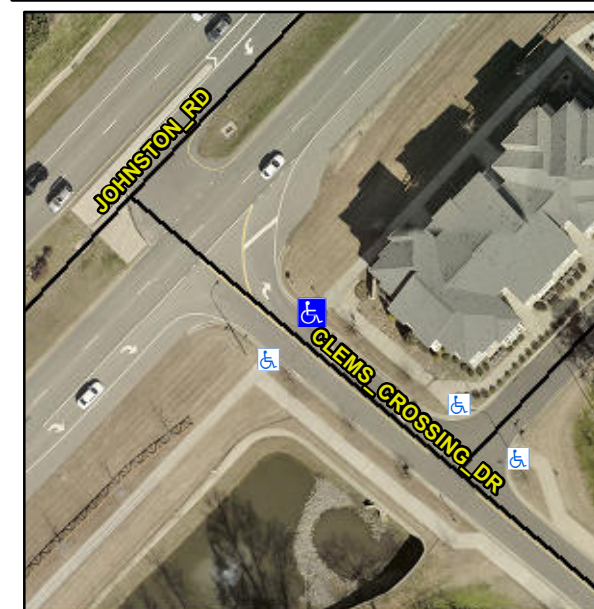
| ADA ID: 5D9C231C845E | Ramp Type: BlendTrans1 | Initial Pass/Fail: Fail | Overall Compliance: No |
| Severity Score: 1.25 | | | |

Not Found, R304.5.3

| Compliance | Description | Data | Compliance | Description | Data |
|---|---|---|---|---|---|
| Yes | Ramp Width (in) | 76.0 | No | BlendTrans XSlope (%) | 2.4 |
| | | | No | Curb Slope (%) | 13.5 |

Remove & Replace Curb Ramp With Two New Directional Ramps or Equivalent.
