Access Compliance Report

Public Rights-of-Way

(Curb Ramps)

Intersection ID: 14765	Main Street: BONNYBROOK_LN	Cross Street: FARM_POND_LN	Location: SE
ADA ID: 5D9C5B450171	Ramp Type: Directional1	Initial Pass/Fail: Fail	Overall Compliance: No
Severity Score: 21.25			
Codes/Mitigation Info/Possible Solution		Field Measurements/Component Compliance

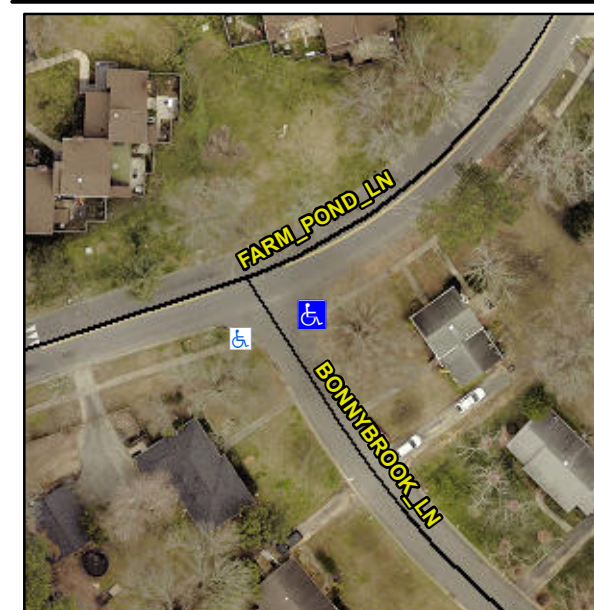
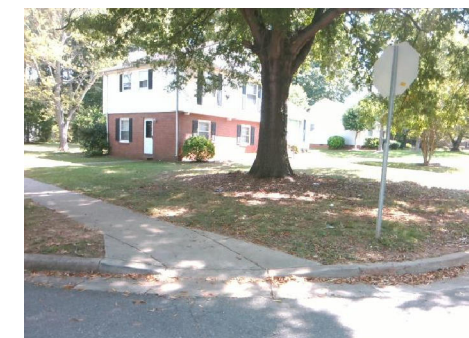
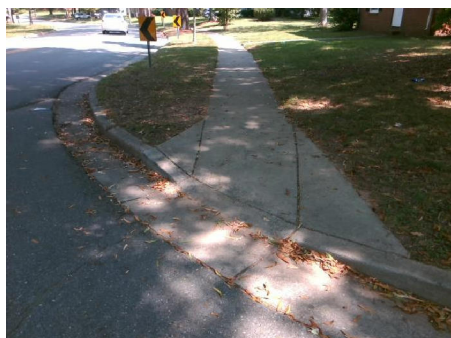
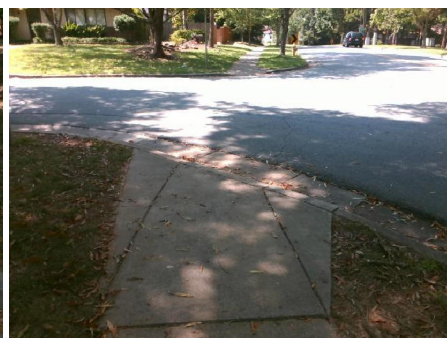
R304.5.1, R304.5.3

Compliance	Description	Data	Compliance	Description	Data
N/A	Ramp Length (in)	72.0	N/A	Grade Break?	N/A
No	Ramp Width (in)	39.0	N/A	Grade Break Slope (%)	0.0
Yes	Ramp Slope (%)	6.0	N/A	Grade Break XSlope (%)	0.0
No	Ramp XSlope (%)	5.3			
N/A	Flare Type LT	N/A	N/A	Flare Type RT	N/A
N/A	Flare Slope LT (%)	N/A	N/A	Flare Slope RT (%)	0.0
N/A	Flare Traversable LT?	N/A	N/A	Flare Traversable RT?	N/A
N/A	Landing Length (in)	0.0	N/A	DWS Provided?	N/A
N/A	Landing Width (in)	0.0	N/A	DWS Contrast?	N/A
N/A	Landing Slope (%)	0.0	N/A	DWS Length (in)	N/A
N/A	Landing X Slope (%)	0.0	N/A	DWS Full Width?	N/A
N/A	Landing Curb? (Y/N)	N/A	N/A	DWS Offset LT (in)	N/A
N/A	Shared Landing?	N/A	N/A	DWS Offset RT (in)	N/A
N/A	Gutter Ponding?	0.0	N/A	Gutter Slope (%)	N/A
N/A	Gutter Lip Ht (in)	0.0	N/A	Gutter X Slope (%)	N/A
N/A	Painted X Walk1?	No		Road Slope (%)	2.1
	X Walk 1 Direction	To W		Road X Slope (%)	0.7
	X Walk 1 Width (in)	N/A		Clear Space?	N/A

X Walk 1 Slope (%)	2.1	N/A	Clear Space to XWalk (in)	N/A
	X Walk 1 X Slope (%)	0.7	N/A	Storm Grate/Utility Hazard?	N/A
N/A	Ramp inside XWalk1?	N/A		Storm Grate/Utility Type	
N/A	Any Obstructions?	N/A			N/A
	Obstruction Type		Yes	Surface Condition? (G/P)	Good
			N/A	Curb Slope (%)	22.3

Remove & Replace Entire Ramp.
