Access Compliance Report

Public Rights-of-Way

(Curb Ramps)

Intersection ID: 30109	Main Street: HARLAND_ST	Cross Street: WANDERING_CREEK_DR	Location: E
ADA ID: 5DACA64C80E7	Ramp Type: PerpDiag	Initial Pass/Fail: Fail	Overall Compliance: No
Severity Score: 33.75			
Codes/Mitigation Info/Possible Solution		Field Measurements/Component Compliance

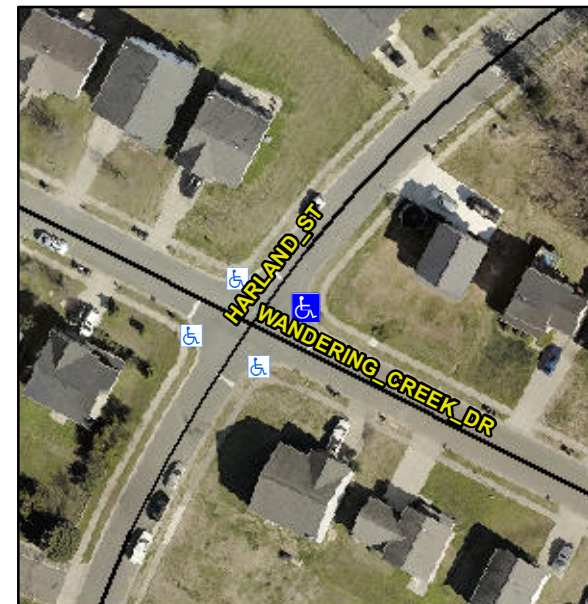
Not Found, R304.5.1, R304.5.3

Compliance	Description	Data	Compliance	Description	Data
N/A	Ramp Length (in)	48.0	Yes	Ramp Slope (%)	5.0
No	Ramp Width (in)	39.0	No	Ramp XSlope (%)	7.0
N/A	Flare Type LT	N/A	N/A	Flare Type RT	N/A
N/A	Flare Slope LT (%)	N/A	N/A	Flare Slope RT (%)	N/A
N/A	Flare Traversable LT?	N/A	N/A	Flare Traversable RT?	N/A
N/A	Landing Length (in)	N/A	N/A	DWS Provided?	N/A
N/A	Landing Width (in)	N/A	N/A	DWS Contrast?	N/A
N/A	Landing Slope (%)	N/A	N/A	DWS Length (in)	N/A
N/A	Landing X Slope (%)	N/A	N/A	DWS Full Width?	N/A
N/A	Landing Curb? (Y/N)	N/A	N/A	DWS Offset (in)	N/A
N/A	Shared Landing?	N/A			
N/A	Gutter Ponding?	N/A	N/A	Gutter Slope (%)	N/A
N/A	Gutter Lip Ht (in)	N/A	N/A	Gutter X Slope (%)	N/A
N/A	Painted X Walk1?	No	N/A	Painted X Walk2?	No
	X Walk 1 Direction	To NW		X Walk 2 Direction	To SW
N/A	X Walk 1 Width (in)	N/A	N/A	X Walk 2 Width (in)	N/A
	X Walk 1 Slope (%)	1.9		X Walk 2 Slope (%)	7.8
	X Walk 1 X Slope (%)	7.1		X Walk 2 X Slope (%)	0.9

N/A	Ramp inside XWalk1?	N/A	N/A	Ramp inside XWalk2?	N/A
	Road Slope (%)	6.6	N/A	Clear Space?	N/A
	Road X Slope (%)	4.6	N/A	Clear Space to XWalk (in)	N/A
N/A	Any Obstructions?	N/A	N/A	Storm Grate/Utility Hazard?	N/A
	Obstruction Type			Storm Grate/Utility Type	
		N/A			N/A
			Yes	Surface Condition? (G/P)	Good

Remove & Replace Curb Ramp With Two New Directional Ramps or Equivalent.
