# Access Compliance Report

## Public Rights-of-Way

### (Curb Ramps)

Intersection ID: 11745	Main Street: E_19TH_ST	Cross Street: HARRILL_ST	Location: E
ADA ID: 5DB1482A763D	Ramp Type: PerpDiag	Initial Pass/Fail: Fail	Overall Compliance: No
			Severity Score: 21.25

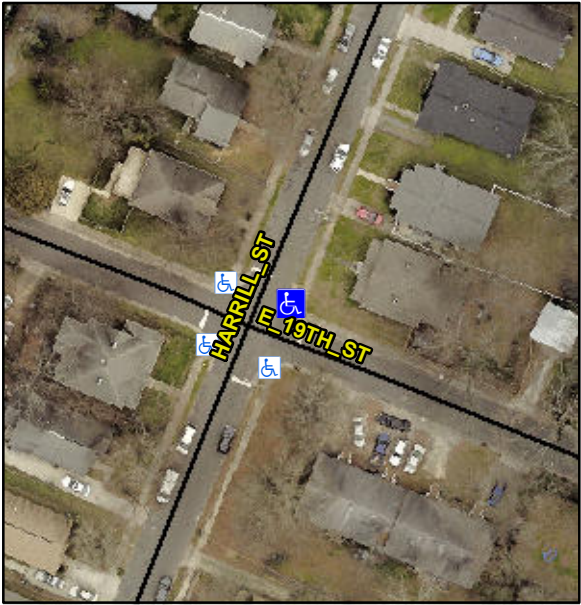
Possible Solutions:		<b>Compliance</b>	<b>Description</b>	<b>Data</b>
	<b>Remove &amp; Replace Curb Ramp With Two New Directional Ramps or Equivalent.</b>		N/A	Ramp Length (in)	52.0
			No	Ramp Width (in)	36.0
			N/A	Flare Type LT	N/A
			N/A	Flare Slope LT (%)	N/A
			N/A	Flare Traversable LT?	N/A
			N/A	Landing Length (in)	N/A
			N/A	Landing Width (in)	N/A
			N/A	Landing Slope (%)	N/A
			N/A	Landing X Slope (%)	N/A
<p>Surveyor Notes:</p> <p><b>N/A</b></p> <p>PROW/ADA:</p> <p><b>R304.5.1, R304.5.3</b></p>			N/A	Flare Type RT	N/A
			N/A	Flare Slope RT (%)	N/A
			N/A	Flare Traversable RT?	N/A
			N/A	DWS Provided?	N/A
			N/A	DWS Contrast?	N/A
			N/A	DWS Length (in)	N/A
			N/A	DWS Full Width?	N/A
			N/A	DWS Offset (in)	N/A
			N/A	Gutter Ponding?	N/A
			N/A	Gutter Lip Ht (in)	N/A
			N/A	Painted X Walk1?	No
				X Walk 1 Direction	To NW

N/A	X Walk 1 Width (in)	N/A
				X Walk 1 Slope (%)	2.6
				X Walk 1 X Slope (%)	5.1
			N/A	Ramp inside XWalk1?	N/A
				Road Slope (%)	3.4
				Road X Slope (%)	6.0
			N/A	Any Obstructions?	N/A
				Obstruction Type	
Total Cost:		\$ 3200.00			
			N/A		N/A
			Yes	Surface Condition? (G/P)	Good
