Access Compliance Report

Public Rights-of-Way

(Curb Ramps)

Intersection ID: 10033070	Main Street: NORTH_COMMUNITY_HOUSE_RD	Cross Street: N/A	Location: SW
ADA ID: 5DB8D284B1B7	Ramp Type: Perp	Initial Pass/Fail: Fail	Overall Compliance: No
			Severity Score: 13.75

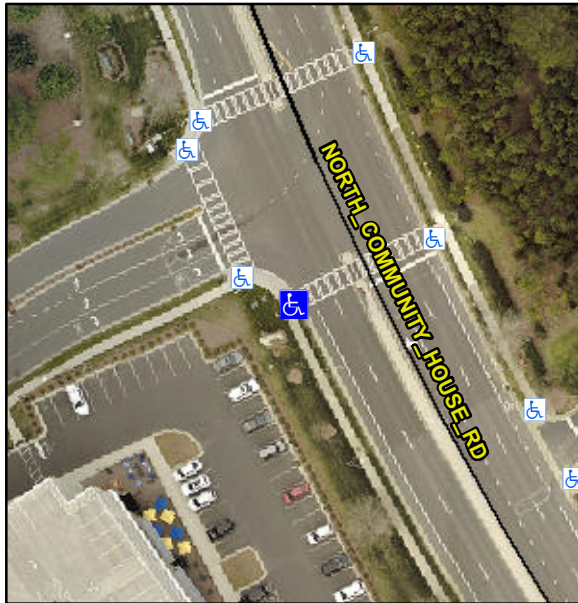
Not Found, R304.2.2

Compliance	Description	Data	Compliance	Description	Data
N/A	Ramp Length (in)	27.0	No	Ramp Slope (%)	10.4
Yes	Ramp Width (in)	48.0	Yes	Ramp XSlope (%)	2.7
N/A	Flare Type LT	N/A	N/A	Flare Type RT	N/A
N/A	Flare Slope LT (%)	N/A	N/A	Flare Slope RT (%)	N/A
N/A	Flare Traversable LT?	N/A	N/A	Flare Traversable RT?	N/A
N/A	Landing Length (in)	N/A	N/A	DWS Provided?	N/A
N/A	Landing Width (in)	N/A	N/A	DWS Contrast?	N/A
N/A	Landing Slope (%)	N/A	N/A	DWS Length (in)	N/A
N/A	Landing X Slope (%)	N/A	N/A	DWS Full Width?	N/A
N/A	Landing Curb? (Y/N)	N/A	N/A	DWS Offset (in)	N/A
N/A	Shared Landing?	N/A			
N/A	Gutter Ponding?	N/A	N/A	Gutter Slope (%)	N/A
N/A	Gutter Lip Ht (in)	N/A	N/A	Gutter X Slope (%)	N/A
N/A	Painted X Walk1?	Yes	N/A	Painted X Walk2?	N/A
	X Walk 1 Direction	To NE		X Walk 2 Direction	N/A
N/A	X Walk 1 Width (in)	111.5	N/A	X Walk 2 Width (in)	N/A
	X Walk 1 Slope (%)	2.1		X Walk 2 Slope (%)	N/A
	X Walk 1 X Slope (%)	3.2		X Walk 2 X Slope (%)	N/A

N/A	Ramp inside XWalk1?	Yes	N/A	Ramp inside XWalk2?	N/A
	Road Slope (%)	N/A	N/A	Clear Space?	N/A
	Road X Slope (%)	N/A	N/A	Clear Space to XWalk (in)	N/A
N/A	Any Obstructions?	N/A	N/A	Storm Grate/Utility Hazard?	N/A
	Obstruction Type			Storm Grate/Utility Type	
		N/A			N/A
			Yes	Surface Condition? (G/P)	Good

Remove & Replace Entire Ramp.
