Access Compliance Report

Public Rights-of-Way

(Curb Ramps)

Intersection ID: 20640	Main Street: S_TRYON_ST	Cross Street: YAGER_CREEK_DR	Location: N
ADA ID: 5DBFACEF5C31	Ramp Type: Perp	Initial Pass/Fail: Fail	Overall Compliance: No
			Severity Score: 33.75

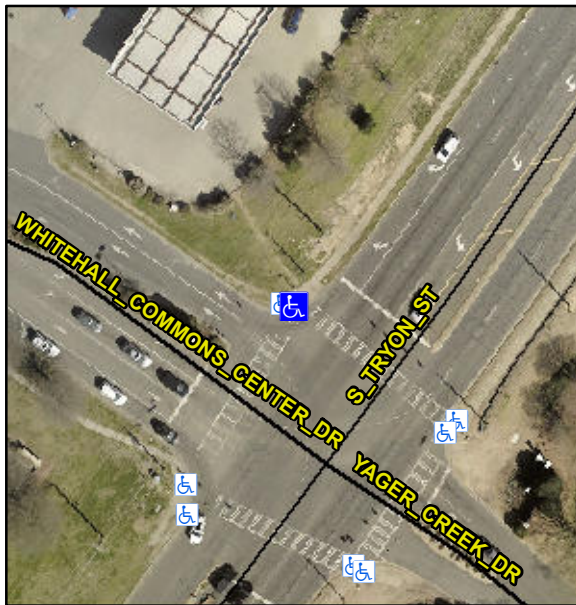
**Not Found, R304.5.1, R304.2.2,
R304.5.3**

Compliance	Description	Data	Compliance	Description	Data
N/A	Ramp Length (in)	89.0	No	Ramp Slope (%)	8.6
No	Ramp Width (in)	43.5	No	Ramp XSlope (%)	6.2
N/A	Flare Type LT	N/A	N/A	Flare Type RT	N/A
N/A	Flare Slope LT (%)	N/A	N/A	Flare Slope RT (%)	N/A
N/A	Flare Traversable LT?	N/A	N/A	Flare Traversable RT?	N/A
N/A	Landing Length (in)	N/A	N/A	DWS Provided?	N/A
N/A	Landing Width (in)	N/A	N/A	DWS Contrast?	N/A
N/A	Landing Slope (%)	N/A	N/A	DWS Length (in)	N/A
N/A	Landing X Slope (%)	N/A	N/A	DWS Full Width?	N/A
N/A	Landing Curb? (Y/N)	N/A	N/A	DWS Offset (in)	N/A
N/A	Shared Landing?	N/A			
N/A	Gutter Ponding?	N/A	N/A	Gutter Slope (%)	N/A
N/A	Gutter Lip Ht (in)	N/A	N/A	Gutter X Slope (%)	N/A
N/A	Painted X Walk1?	Yes	N/A	Painted X Walk2?	N/A
	X Walk 1 Direction	To SE		X Walk 2 Direction	N/A
N/A	X Walk 1 Width (in)	109.0	N/A	X Walk 2 Width (in)	N/A
	X Walk 1 Slope (%)	0.7		X Walk 2 Slope (%)	N/A
	X Walk 1 X Slope (%)	4.4		X Walk 2 X Slope (%)	N/A

N/A	Ramp inside XWalk1?	No	N/A	Ramp inside XWalk2?	N/A
	Road Slope (%)	N/A	N/A	Clear Space?	N/A
	Road X Slope (%)	N/A	N/A	Clear Space to XWalk (in)	N/A
N/A	Any Obstructions?	N/A	N/A	Storm Grate/Utility Hazard?	N/A
	Obstruction Type			Storm Grate/Utility Type	
		N/A			N/A
			Yes	Surface Condition? (G/P)	Good

**Remove & Replace Entire Ramp.
Restripe Crosswalk.**
