Access Compliance Report

Public Rights-of-Way

(Curb Ramps)

Intersection ID: N/A	Main Street: CLAVEMORR GLENN CT	Cross Street: CALLEY_GLENN_LN	Location: SW
ADA ID: 5DC373AB8E3D	Ramp Type: PerpDiag	Initial Pass/Fail: Fail	Overall Compliance: No
Severity Score: 8.75			
Codes/Mitigation Info/Possible Solution		Field Measurements/Component Compliance

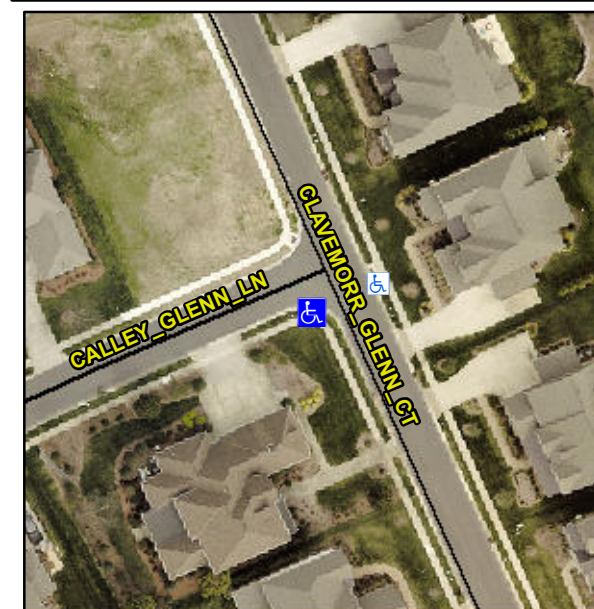
Not Found, R304.5.1

Compliance	Description	Data	Compliance	Description	Data
N/A	Ramp Length (in)	48.0	Yes	Ramp Slope (%)	5.9
No	Ramp Width (in)	46.5	Yes	Ramp XSlope (%)	1.6
N/A	Flare Type LT	N/A	N/A	Flare Type RT	N/A
N/A	Flare Slope LT (%)	N/A	N/A	Flare Slope RT (%)	N/A
N/A	Flare Traversable LT?	N/A	N/A	Flare Traversable RT?	N/A
N/A	Landing Length (in)	N/A	N/A	DWS Provided?	N/A
N/A	Landing Width (in)	N/A	N/A	DWS Contrast?	N/A
N/A	Landing Slope (%)	N/A	N/A	DWS Length (in)	N/A
N/A	Landing X Slope (%)	N/A	N/A	DWS Full Width?	N/A
N/A	Landing Curb? (Y/N)	N/A	N/A	DWS Offset (in)	N/A
N/A	Shared Landing?	N/A			
N/A	Gutter Ponding?	N/A	N/A	Gutter Slope (%)	N/A
N/A	Gutter Lip Ht (in)	N/A	N/A	Gutter X Slope (%)	N/A
N/A	Painted X Walk1?	No	N/A	Painted X Walk2?	No
	X Walk 1 Direction	To E		X Walk 2 Direction	To N
N/A	X Walk 1 Width (in)	N/A	N/A	X Walk 2 Width (in)	N/A
	X Walk 1 Slope (%)	1.6		X Walk 2 Slope (%)	0.8
	X Walk 1 X Slope (%)	0.6		X Walk 2 X Slope (%)	0.6

N/A	Ramp inside XWalk1?	N/A	N/A	Ramp inside XWalk2?	N/A
	Road Slope (%)	1.9	N/A	Clear Space?	N/A
	Road X Slope (%)	1.1	N/A	Clear Space to XWalk (in)	N/A
N/A	Any Obstructions?	N/A	N/A	Storm Grate/Utility Hazard?	N/A
	Obstruction Type			Storm Grate/Utility Type	
		N/A			N/A
		Yes		Surface Condition? (G/P)	Good

Possible Solutions:

Remove & Replace Curb Ramp With Two New Directional Ramps or Equivalent.
