Access Compliance Report Public Rights-of-Way (Curb Ramps)

Intersection ID: 50464Main Street:LENOX_POINTE_DRCross Street:SANDY_PORTER_RDLocation:NWADA ID: 5DC5F364D464Ramp Type:PerpInitial Pass/Fail:FailOverall Compliance:NoSeverity Score:1.25

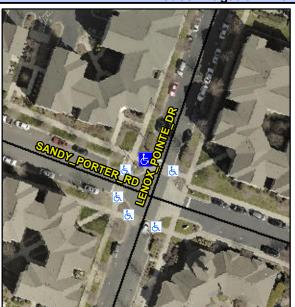
Comp	liance Description	Data	Comp	liance Description	Data
N/A	Ramp Length (in)	130.5	Yes	Ramp Slope (%)	6.3
Yes	Ramp Width (in)	48.0	No	Ramp XSlope (%)	2.6
N/A	Flare Type LT	N/A	N/A	I/ A Flare Type RT	
N/A	Flare Slope LT (%)	N/A	N/A	N/A Flare Slope RT (%)	
N/A	Flare Traversable LT?	N/A	N/A	Flare Traversable RT?	N/A
N/A	Landing Length (in)	N/A	N/A	DWS Provided?	N/A
N/A	Landing Width (in)	N/A	N/A	DWS Contrast?	N/A
N/A	Landing Slope (%)	N/A	N/A	DWS Length (in)	N/A
N/A	Landing X Slope (%)	N/A	N/A	DWS Full Width?	N/A
N/A	Landing Curb? (Y/N)	N/A	N/A	DWS Offset (in)	N/A
N/A	Shared Landing?	N/A			
N/A	Gutter Ponding?	N/A	N/A	Gutter Slope (%)	N/A
N/A	Gutter Lip Ht (in)	N/A	N/A	Gutter X Slope (%)	N/A
N/A	Painted X Walk1?	Yes	N/A	Painted X Walk2?	N/A
	X Walk 1 Direction	To E		X Walk 2 Direction	N/A
N/A	X Walk 1 Width (in)	144.0	N/A	X Walk 2 Width (in)	N/A
	X Walk 1 Slope (%)	1.0		X Walk 2 Slope (%)	N/A
	X Walk 1 X Slope (%)	1.3		X Walk 2 X Slope (%)	N/A

N/A	Ramp inside XWalk1?	Yes	N/A	Ramp inside XWalk2?	N/A
	Road Slope (%)	N/A	N/A	Clear Space?	N/A
	Road X Slope (%)	N/A	N/A	Clear Space to XWalk (in)	N/A
N/A	Any Obstructions?	N/A	N/A	Storm Grate/Utility Hazard?	N/A
	Obstruction Type			Storm Grate/Utility Type	
		N/A			N/A
			Yes	Surface Condition? (G/P)	Good

Possible Solution	
Possible Solutions:	Con
Remove & Replace Entire Ramp.	N/A
·	Yes
	N/A
	N/A
	N/A
	N/A
Surveyor Notes:	N/A
N/A	N/A
	N/A
	N/A
	N/A
PROW/ADA:	N/A
Not Found, R304.5.3	N/A
,	N/A
	N/A
	N/A

Total Cost:	\$ 1850.00
