Access Compliance Report

Public Rights-of-Way

(Curb Ramps)

Intersection ID: 50335	Main Street: MILLIE_LN	Cross Street: LEVY_WY	Location: SW
ADA ID: 5DC6AFBB34D7	Ramp Type: PerpDiag	Initial Pass/Fail: Fail	Overall Compliance: No
Codes/Mitigation Info/Possible Solution		Field Measurements/Component Compliance	
Severity Score: 33.75

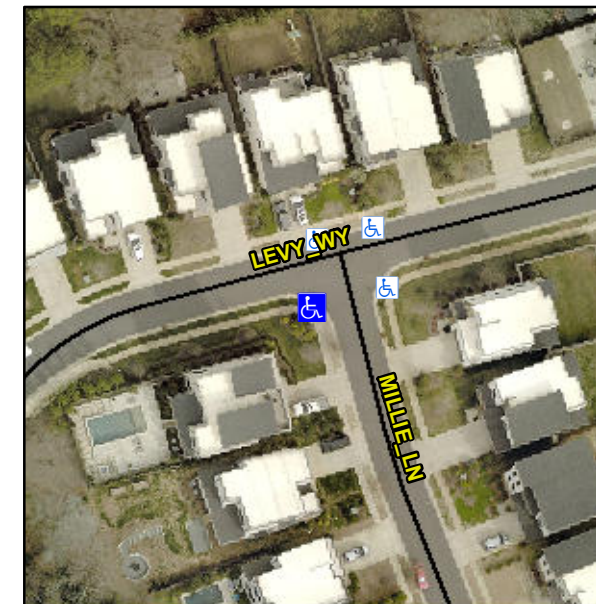
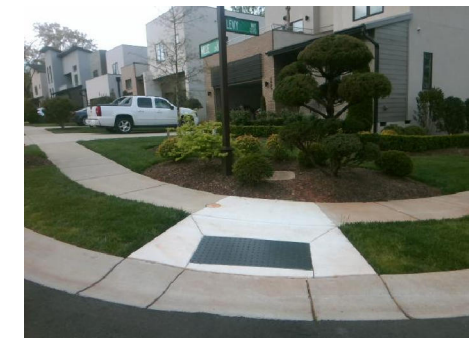
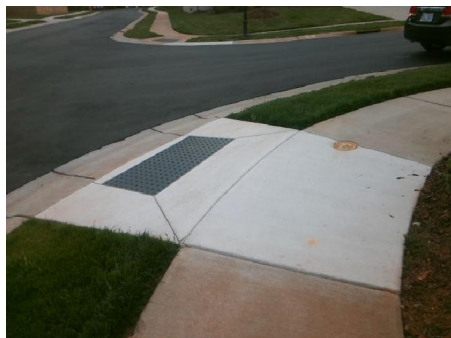
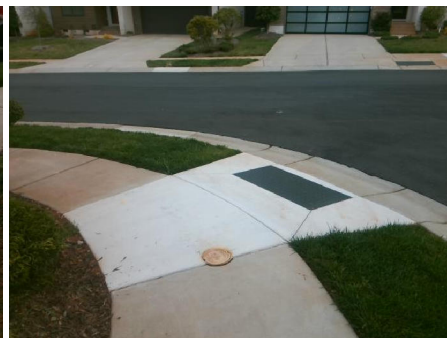
Not Found, R304.5.1, R304.2.2, R304.5.3

Compliance	Description	Data	Compliance	Description	Data
N/A	Ramp Length (in)	49.0	No	Ramp Slope (%)	9.8
No	Ramp Width (in)	45.5	No	Ramp XSlope (%)	6.7
N/A	Flare Type LT	N/A	N/A	Flare Type RT	N/A
N/A	Flare Slope LT (%)	N/A	N/A	Flare Slope RT (%)	N/A
N/A	Flare Traversable LT?	N/A	N/A	Flare Traversable RT?	N/A
N/A	Landing Length (in)	N/A	N/A	DWS Provided?	N/A
N/A	Landing Width (in)	N/A	N/A	DWS Contrast?	N/A
N/A	Landing Slope (%)	N/A	N/A	DWS Length (in)	N/A
N/A	Landing X Slope (%)	N/A	N/A	DWS Full Width?	N/A
N/A	Landing Curb? (Y/N)	N/A	N/A	DWS Offset (in)	N/A
N/A	Shared Landing?	N/A			
N/A	Gutter Ponding?	N/A	N/A	Gutter Slope (%)	N/A
N/A	Gutter Lip Ht (in)	N/A	N/A	Gutter X Slope (%)	N/A
N/A	Painted X Walk1?	No	N/A	Painted X Walk2?	No
	X Walk 1 Direction	To E		X Walk 2 Direction	To N
N/A	X Walk 1 Width (in)	N/A	N/A	X Walk 2 Width (in)	N/A
	X Walk 1 Slope (%)	3.4		X Walk 2 Slope (%)	2.1
	X Walk 1 X Slope (%)	2.9		X Walk 2 X Slope (%)	4.2

N/A	Ramp inside XWalk1?	N/A	N/A	Ramp inside XWalk2?	N/A
	Road Slope (%)	3.7	N/A	Clear Space?	N/A
	Road X Slope (%)	0.2	N/A	Clear Space to XWalk (in)	N/A
N/A	Any Obstructions?	N/A	N/A	Storm Grate/Utility Hazard?	N/A
	Obstruction Type			Storm Grate/Utility Type	
		N/A			N/A
			Yes	Surface Condition? (G/P)	Good

Remove & Replace Curb Ramp With Two New Directional Ramps or Equivalent.

Total Cost: \$ 3200.00
