Access Compliance Report

Public Rights-of-Way

(Curb Ramps)

Intersection ID: 48431	Main Street: SEAMILL_RD	Cross Street: KINNAIRDS_ST	Location: NE
ADA ID: 5DCD1A3DD05E	Ramp Type: PerpDiag	Initial Pass/Fail: Fail	Overall Compliance: No
Severity Score: 21.25			
Codes/Mitigation Info/Possible Solution		Field Measurements/Component Compliance

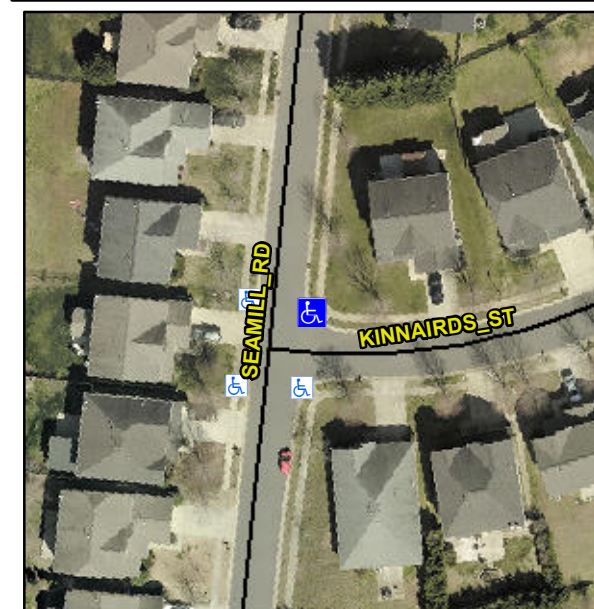
Not Found, R304.5.1, R304.2.2

Compliance	Description	Data	Compliance	Description	Data
N/A	Ramp Length (in)	47.0	No	Ramp Slope (%)	8.5
No	Ramp Width (in)	47.5	Yes	Ramp XSlope (%)	0.4
N/A	Flare Type LT	N/A	N/A	Flare Type RT	N/A
N/A	Flare Slope LT (%)	N/A	N/A	Flare Slope RT (%)	N/A
N/A	Flare Traversable LT?	N/A	N/A	Flare Traversable RT?	N/A
N/A	Landing Length (in)	N/A	N/A	DWS Provided?	N/A
N/A	Landing Width (in)	N/A	N/A	DWS Contrast?	N/A
N/A	Landing Slope (%)	N/A	N/A	DWS Length (in)	N/A
N/A	Landing X Slope (%)	N/A	N/A	DWS Full Width?	N/A
N/A	Landing Curb? (Y/N)	N/A	N/A	DWS Offset (in)	N/A
N/A	Shared Landing?	N/A			
N/A	Gutter Ponding?	N/A	N/A	Gutter Slope (%)	N/A
N/A	Gutter Lip Ht (in)	N/A	N/A	Gutter X Slope (%)	N/A
N/A	Painted X Walk1?	No	N/A	Painted X Walk2?	No
	X Walk 1 Direction	To NW		X Walk 2 Direction	To SW
N/A	X Walk 1 Width (in)	N/A	N/A	X Walk 2 Width (in)	N/A
	X Walk 1 Slope (%)	1.1		X Walk 2 Slope (%)	2.0
	X Walk 1 X Slope (%)	2.4		X Walk 2 X Slope (%)	2.9

N/A	Ramp inside XWalk1?	N/A	N/A	Ramp inside XWalk2?	N/A
	Road Slope (%)	1.2	N/A	Clear Space?	N/A
	Road X Slope (%)	1.5	N/A	Clear Space to XWalk (in)	N/A
N/A	Any Obstructions?	N/A	N/A	Storm Grate/Utility Hazard?	N/A
	Obstruction Type			Storm Grate/Utility Type	
		N/A			N/A
			Yes	Surface Condition? (G/P)	Good

Possible Solutions:

Remove & Replace Curb Ramp With Two New Directional Ramps or Equivalent.
