# Access Compliance Report

## Public Rights-of-Way

Intersection ID: 20292	Main Street: BENTLEY_OAKS_LN	Cross Street: SARDIS_RD	Location: SW
ADA ID: 5DD44DECA819	Ramp Type: PerpDiag	Initial Pass/Fail: Fail	Overall Compliance: No
Severity Score: 21.25			
Codes/Mitigation Info/Possible Solution		Field Measurements/Component Compliance

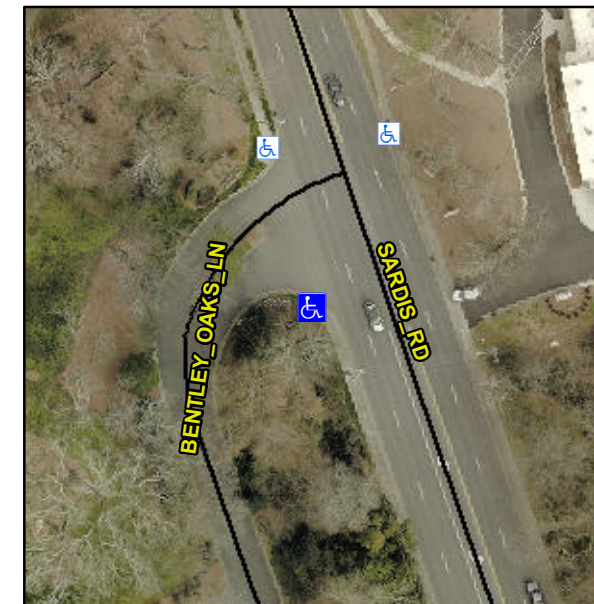
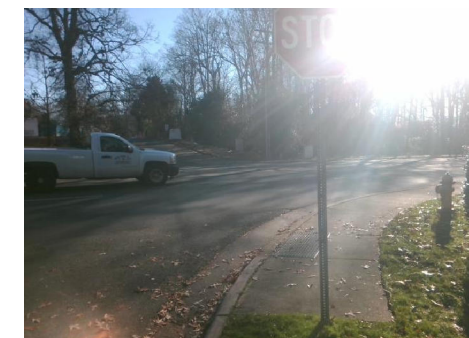
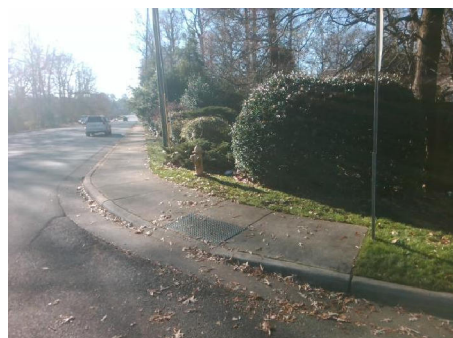
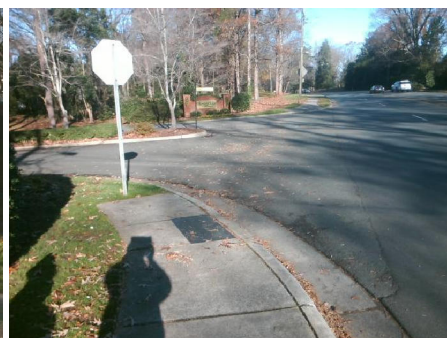
**Not Found, R304.5.1, R304.5.3**

Compliance	Description	Data	Compliance	Description	Data
N/A	Ramp Length (in)	60.0	Yes	Ramp Slope (%)	7.1
No	Ramp Width (in)	42.5	No	Ramp XSlope (%)	5.1
N/A	Flare Type LT	N/A	N/A	Flare Type RT	N/A
N/A	Flare Slope LT (%)	N/A	N/A	Flare Slope RT (%)	N/A
N/A	Flare Traversable LT?	N/A	N/A	Flare Traversable RT?	N/A
N/A	Landing Length (in)	N/A	N/A	DWS Provided?	N/A
N/A	Landing Width (in)	N/A	N/A	DWS Contrast?	N/A
N/A	Landing Slope (%)	N/A	N/A	DWS Length (in)	N/A
N/A	Landing X Slope (%)	N/A	N/A	DWS Full Width?	N/A
N/A	Landing Curb? (Y/N)	N/A	N/A	DWS Offset (in)	N/A
N/A	Shared Landing?	N/A			
N/A	Gutter Ponding?	N/A	N/A	Gutter Slope (%)	N/A
N/A	Gutter Lip Ht (in)	N/A	N/A	Gutter X Slope (%)	N/A
N/A	Painted X Walk1?	No	N/A	Painted X Walk2?	No
	X Walk 1 Direction	To NE		X Walk 2 Direction	To NW
N/A	X Walk 1 Width (in)	N/A	N/A	X Walk 2 Width (in)	N/A
	X Walk 1 Slope (%)	5.9		X Walk 2 Slope (%)	1.3
	X Walk 1 X Slope (%)	2.5		X Walk 2 X Slope (%)	6.0

N/A	Ramp inside XWalk1?	N/A	N/A	Ramp inside XWalk2?	N/A
	Road Slope (%)	1.7	N/A	Clear Space?	N/A
	Road X Slope (%)	5.8	N/A	Clear Space to XWalk (in)	N/A
N/A	Any Obstructions?	N/A	N/A	Storm Grate/Utility Hazard?	N/A
	Obstruction Type			Storm Grate/Utility Type	
		N/A			N/A
			Yes	Surface Condition? (G/P)	Good

**Remove & Replace Curb Ramp With Two New Directional Ramps or Equivalent.**
