## **Access Compliance Report Public Rights-of-Way** (Curb Ramps)

Intersection ID: 10247 Main Street: BURTON ST **Cross Street: WHISNANT ST** Location: **Overall Compliance: No** ADA ID: 5DD77850217C Ramp Type: Combination2 Initial Pass/Fail: Fail Severity Score: 33.75

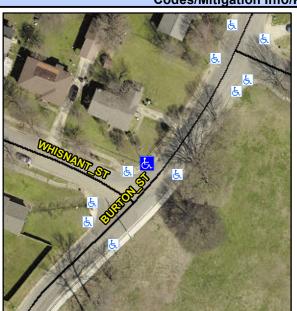
Compliance Description Possible Solutions: N/A Remove & Replace Entire Ramp. N/A N/A N/A N/A No Surveyor Notes: N/A LT RP < 5% N/A N/A N/A N/A PROW/ADA: N/A Not Found, R304.5.1, R304.5.3 N/A N/A N/A N/A N/A N/A
