# Access Compliance Report

## Public Rights-of-Way

### (Curb Ramps)

| Intersection ID: 44602 | Main Street: JOHNSTON_OEHLE_R_D | Cross Street: PROSPERITY_PARK_DR | Location: NE |

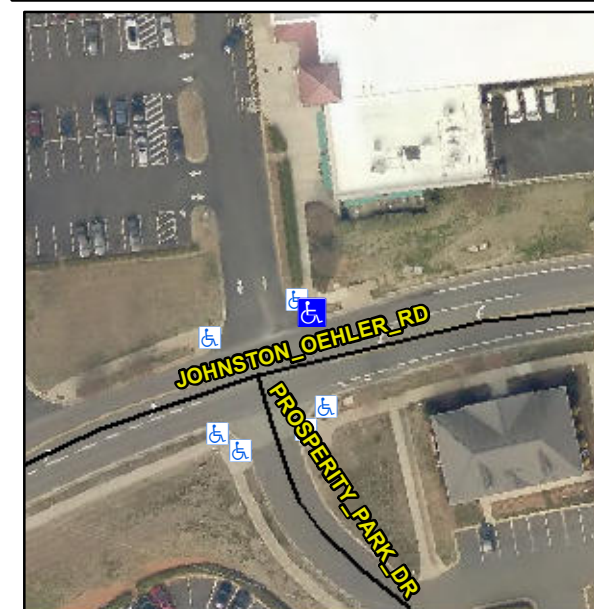
| ADA ID: 5DE1F86987CE | Ramp Type: PerpDiag | Initial Pass/Fail: Fail | Overall Compliance: No |

| Codes/Mitigation Info/Possible Solution | | | Severity Score: 30 |

**R304.5.1, R304.2.2**

| Compliance | Description | Data | Compliance | Description | Data |
|---|---|---|---|---|---|
| N/A | Ramp Length (in) | 62.5 | No | Ramp Slope (%) | 9.1 |
| No | Ramp Width (in) | 33.0 | Yes | Ramp XSlope (%) | 1.1 |

**Remove & Replace Curb Ramp With Two New Directional Ramps or Equivalent.**

Total Cost: \$ 3200.00
