Access Compliance Report

Public Rights-of-Way

(Curb Ramps)

Intersection ID: N/A	Main Street: SAM_NEELY_RD	Cross Street: STEELE_CREEK_RD	Location: SW
ADA ID: 5DE37E292224	Ramp Type: Perp	Initial Pass/Fail: Fail	Overall Compliance: No
Severity Score: 33.75			
Codes/Mitigation Info/Possible Solution		Field Measurements/Component Compliance

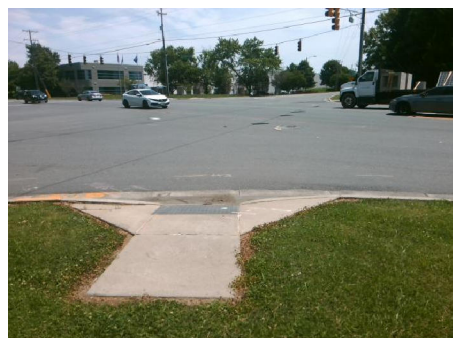
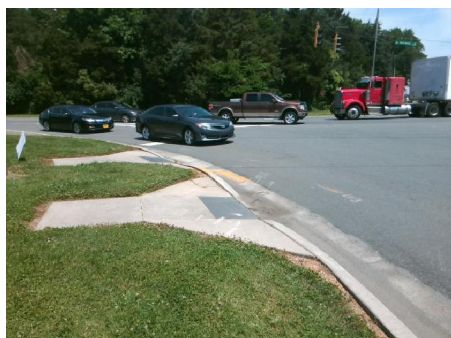
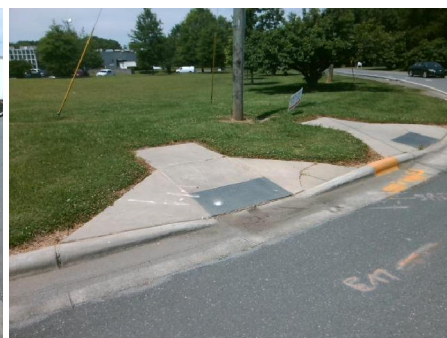
Not Found, R304.5.1, R304.2.2

Compliance	Description	Data	Compliance	Description	Data
N/A	Ramp Length (in)	63.0	No	Ramp Slope (%)	12.9
No	Ramp Width (in)	46.0	Yes	Ramp XSlope (%)	1.8
N/A	Flare Type LT	N/A	N/A	Flare Type RT	N/A
N/A	Flare Slope LT (%)	N/A	N/A	Flare Slope RT (%)	N/A
N/A	Flare Traversable LT?	N/A	N/A	Flare Traversable RT?	N/A
N/A	Landing Length (in)	N/A	N/A	DWS Provided?	N/A
N/A	Landing Width (in)	N/A	N/A	DWS Contrast?	N/A
N/A	Landing Slope (%)	N/A	N/A	DWS Length (in)	N/A
N/A	Landing X Slope (%)	N/A	N/A	DWS Full Width?	N/A
N/A	Landing Curb? (Y/N)	N/A	N/A	DWS Offset (in)	N/A
N/A	Shared Landing?	N/A			
N/A	Gutter Ponding?	N/A	N/A	Gutter Slope (%)	N/A
N/A	Gutter Lip Ht (in)	N/A	N/A	Gutter X Slope (%)	N/A
N/A	Painted X Walk1?	No	N/A	Painted X Walk2?	N/A
	X Walk 1 Direction	To E		X Walk 2 Direction	N/A
N/A	X Walk 1 Width (in)	N/A	N/A	X Walk 2 Width (in)	N/A
	X Walk 1 Slope (%)	2.1		X Walk 2 Slope (%)	N/A
	X Walk 1 X Slope (%)	1.3		X Walk 2 X Slope (%)	N/A

N/A	Ramp inside XWalk1?	N/A	N/A	Ramp inside XWalk2?	N/A
	Road Slope (%)	N/A	N/A	Clear Space?	N/A
	Road X Slope (%)	N/A	N/A	Clear Space to XWalk (in)	N/A
N/A	Any Obstructions?	N/A	N/A	Storm Grate/Utility Hazard?	N/A
	Obstruction Type			Storm Grate/Utility Type	
		N/A			N/A
			Yes	Surface Condition? (G/P)	Good

Remove & Replace Entire Ramp.

Total Cost: \$ 1850.00
