Access Compliance Report

Public Rights-of-Way

(Curb Ramps)

Intersection ID: 52784	Main Street: SARDIS_HALL_CT	Cross Street: SARDIS_RD	Location: SW
ADA ID: 5DF380132683	Ramp Type: PerpDiag	Initial Pass/Fail: Fail	Overall Compliance: No
Severity Score: 33.75			
Codes/Mitigation Info/Possible Solution		Field Measurements/Component Compliance

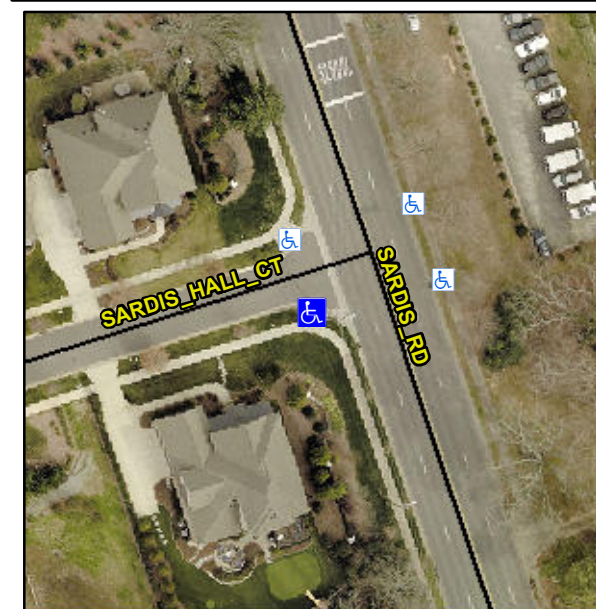
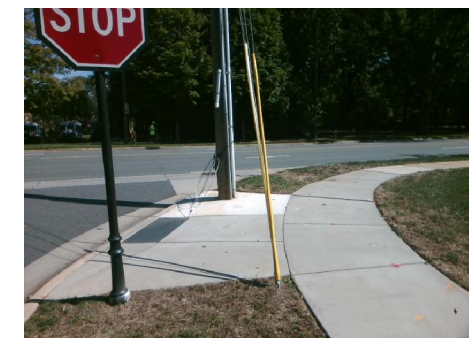
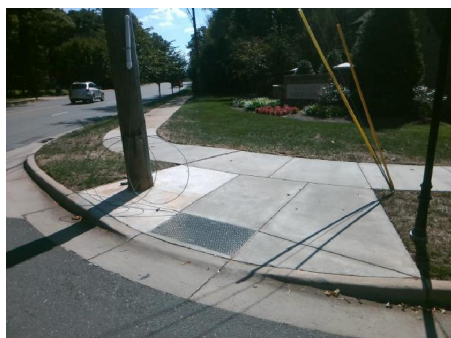
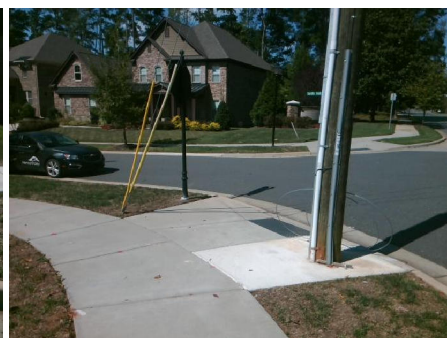
Compliance	Description	Data	Compliance	Description	Data
N/A	Ramp Length (in)	94.5	No	Ramp Slope (%)	8.9
No	Ramp Width (in)	47.0	No	Ramp XSlope (%)	5.8
N/A	Flare Type LT	N/A	N/A	Flare Type RT	N/A
N/A	Flare Slope LT (%)	N/A	N/A	Flare Slope RT (%)	N/A
N/A	Flare Traversable LT?	N/A	N/A	Flare Traversable RT?	N/A
N/A	Landing Length (in)	N/A	N/A	DWS Provided?	N/A
N/A	Landing Width (in)	N/A	N/A	DWS Contrast?	N/A
N/A	Landing Slope (%)	N/A	N/A	DWS Length (in)	N/A
N/A	Landing X Slope (%)	N/A	N/A	DWS Full Width?	N/A
N/A	Landing Curb? (Y/N)	N/A	N/A	DWS Offset (in)	N/A
N/A	Shared Landing?	N/A			
N/A	Gutter Ponding?	N/A	N/A	Gutter Slope (%)	N/A
N/A	Gutter Lip Ht (in)	N/A	N/A	Gutter X Slope (%)	N/A
N/A	Painted X Walk1?	No	N/A	Painted X Walk2?	No
	X Walk 1 Direction	To E		X Walk 2 Direction	To N
N/A	X Walk 1 Width (in)	N/A	N/A	X Walk 2 Width (in)	N/A
	X Walk 1 Slope (%)	7.9		X Walk 2 Slope (%)	1.8
	X Walk 1 X Slope (%)	2.4		X Walk 2 X Slope (%)	5.8

N/A	Ramp inside XWalk1?	N/A	N/A	Ramp inside XWalk2?	N/A
	Road Slope (%)	2.7	N/A	Clear Space?	N/A
	Road X Slope (%)	7.0	N/A	Clear Space to XWalk (in)	N/A
N/A	Any Obstructions?	N/A	N/A	Storm Grate/Utility Hazard?	N/A
	Obstruction Type			Storm Grate/Utility Type	
		N/A			N/A
			Yes	Surface Condition? (G/P)	Good

Possible Solutions:

Remove & Replace Curb Ramp With Two New Directional Ramps or Equivalent.

R304.5.1, R304.2.2, R304.5.3
