Access Compliance Report

Public Rights-of-Way

(Curb Ramps)

Intersection ID: 43154	Main Street: KILDARE_DR	Cross Street: SHANNONHOUSE_DR	Location: NW
ADA ID: 5DF55BF46D06	Ramp Type: BlendTrans2	Initial Pass/Fail: Fail	Overall Compliance: No
		Severity Score: 12.5

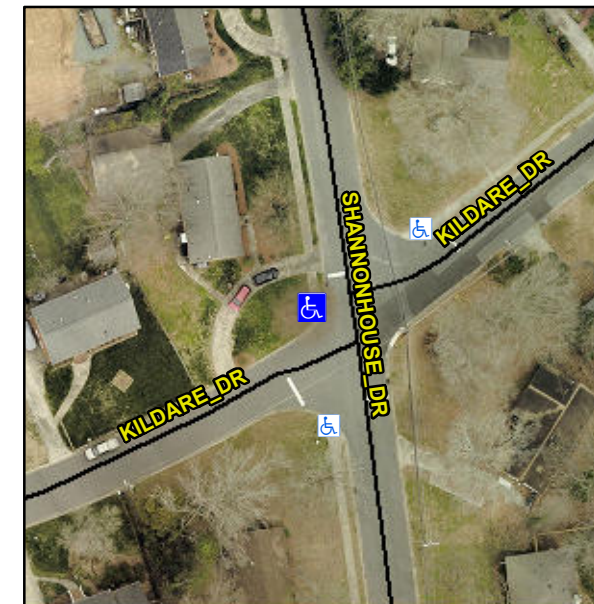
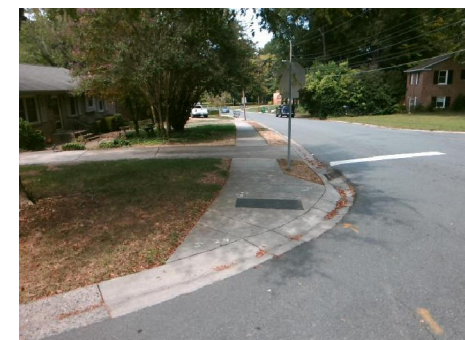
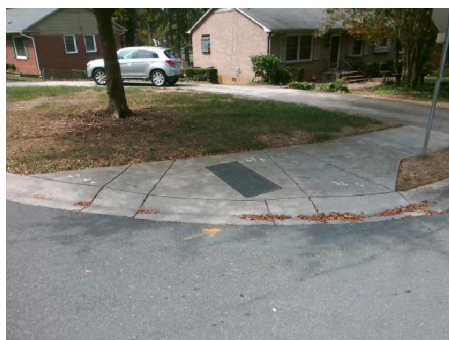
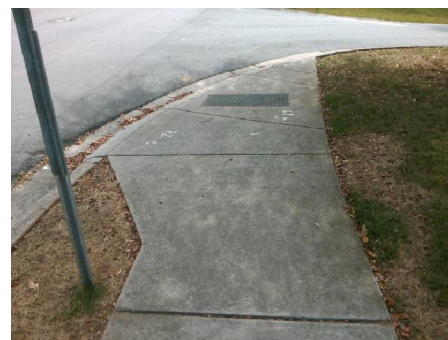
Compliance	Description	Data	Compliance	Description	Data
N/A	Ramp Length (in)	174.0	Yes	BlendTrans Slope (%)	2.9
Yes	Ramp Width (in)	59.0	No	BlendTrans XSlope (%)	6.9
N/A	Flare Type LT	N/A	N/A	Flare Type RT	N/A
N/A	Flare Slope LT (%)	N/A	N/A	Flare Slope RT (%)	N/A
N/A	Flare Traversable LT?	N/A	N/A	Flare Traversable RT?	N/A
N/A	Landing Length (in)	N/A	N/A	DWS Provided?	N/A
N/A	Landing Width (in)	N/A	N/A	DWS Contrast?	N/A
N/A	Landing Slope (%)	N/A	N/A	DWS Length (in)	N/A
N/A	Landing X Slope (%)	N/A	N/A	DWS Full Width?	N/A
N/A	Landing Curb? (Y/N)	N/A	N/A	DWS Offset (in)	N/A
N/A	Shared Landing?	N/A			
N/A	Gutter Ponding?	N/A	N/A	Gutter Slope (%)	N/A
N/A	Gutter Lip Ht (in)	1.0	N/A	Gutter X Slope (%)	N/A
N/A	Painted X Walk1?	No	N/A	Painted X Walk2?	No
	X Walk 1 Direction	To S		X Walk 2 Direction	To NE
	X Walk 1 Width (in)	N/A		X Walk 2 Width (in)	N/A
	X Walk 1 Slope (%)	5.9		X Walk 2 Slope (%)	2.1
	X Walk 1 X Slope (%)	2.4		X Walk 2 X Slope (%)	7.2

N/A	Ramp inside XWalk1?	N/A	N/A	Ramp inside XWalk2?	N/A
	Road Slope (%)	5.6		Clear Space?	N/A
	Road X Slope (%)	10.8	N/A	Clear Space to XWalk (in)	N/A
N/A	Any Obstructions?	N/A	N/A	Storm Grate/Utility Hazard?	N/A
	Obstruction Type			Storm Grate/Utility Type	
		N/A			N/A
			Yes	Surface Condition? (G/P)	Good
			No	Curb Slope (%)	20.3

Remove & Replace Curb Ramp With Two New Directional Ramps or Equivalent.
