Access Compliance Report

Public Rights-of-Way

(Curb Ramps)

Intersection ID: 11929	Main Street: E_13TH_ST	Cross Street: N_DAVIDSON_ST	Location:	N
ADA ID: 5DF76FCE502F	Ramp Type: Perpendicular	Initial Pass/Fail: Fail	Overall Compliance: No	Severity Score: 25

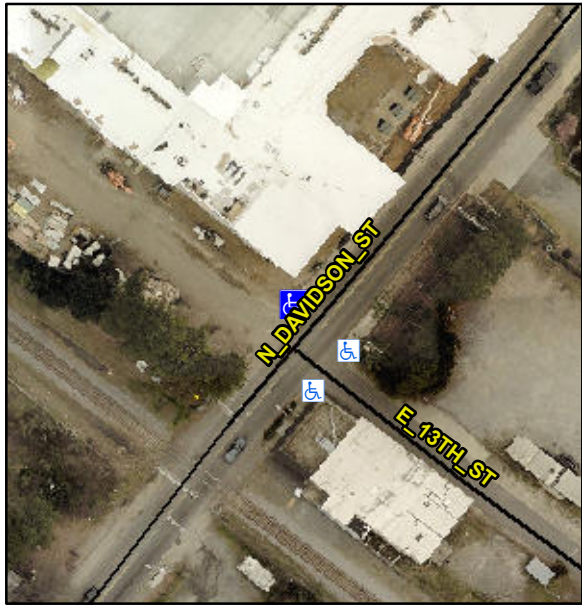
Possible Solutions:		Compliance	Description	Data	Compliance	Description	Data
	Remove & Replace Entire Ramp.		N/A	Ramp Length (in)	30.0	Yes	Ramp Slope (%)	7.0
			Yes	Ramp Width (in)	60.0	No	Ramp XSlope (%)	8.6
			N/A	Flare Type LT	N/A	N/A	Flare Type RT	N/A
			N/A	Flare Slope LT (%)	N/A	N/A	Flare Slope RT (%)	N/A
			N/A	Flare Traversable LT?	N/A	N/A	Flare Traversable RT?	N/A
			N/A	Landing Length (in)	N/A	N/A	DWS Provided?	N/A
			N/A	Landing Width (in)	N/A	N/A	DWS Contrast?	N/A
			N/A	Landing Slope (%)	N/A	N/A	DWS Length (in)	N/A
			N/A	Landing X Slope (%)	N/A	N/A	DWS Full Width?	N/A
Surveyor Notes:			N/A	Landing Curb? (Y/N)	N/A	N/A	DWS Offset (in)	N/A
N/A			N/A	Shared Landing?	N/A			
PROW/ADA:			N/A	Gutter Ponding?	N/A	N/A	Gutter Slope (%)	N/A
R304.5.3			N/A	Gutter Lip Ht (in)	1.0	N/A	Gutter X Slope (%)	N/A
			N/A	Painted X Walk1?	No	N/A	Painted X Walk2?	N/A

X Walk 1 Direction	To SE		X Walk 2 Direction	N/A
			N/A	X Walk 1 Width (in)	N/A	N/A	X Walk 2 Width (in)	N/A
				X Walk 1 Slope (%)	10.1		X Walk 2 Slope (%)	N/A
				X Walk 1 X Slope (%)	5.8		X Walk 2 X Slope (%)	N/A
			N/A	Ramp inside XWalk1?	N/A	N/A	Ramp inside XWalk2?	N/A
				Road Slope (%)	N/A	N/A	Clear Space?	N/A
				Road X Slope (%)	N/A	N/A	Clear Space to XWalk (in)	N/A
			N/A	Any Obstructions?	N/A	N/A	Storm Grate/Utility Hazard?	N/A
				Obstruction Type			Storm Grate/Utility Type	
						N/A		N/A
						Yes	Surface Condition? (G/P)	Good
Total Cost:		\$ 1850.00
