Access Compliance Report

Public Rights-of-Way

(Curb Ramps)

Intersection ID: N/A	Main Street: N COLLEGE ST	Cross Street: E 7TH ST	Location: W
ADA ID: 5DF8CD40D0E7	Ramp Type: PerpDiag	Initial Pass/Fail: Fail	Overall Compliance: No
		Severity Score: 12.5

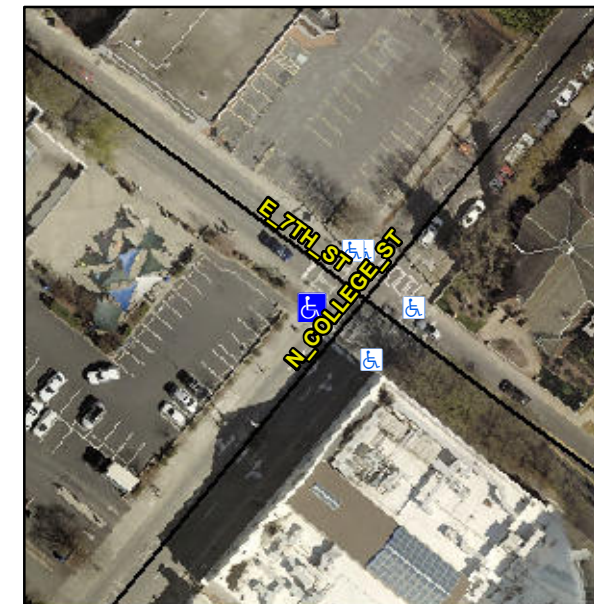
Compliance	Description	Data	Compliance	Description	Data
N/A	Ramp Length (in)	51.0	No	Ramp Slope (%)	8.7
Yes	Ramp Width (in)	93.0	Yes	Ramp XSlope (%)	0.6
N/A	Flare Type LT	N/A	N/A	Flare Type RT	N/A
N/A	Flare Slope LT (%)	N/A	N/A	Flare Slope RT (%)	N/A
N/A	Flare Traversable LT?	No	N/A	Flare Traversable RT?	No
N/A	Landing Length (in)	N/A	N/A	DWS Provided?	N/A
N/A	Landing Width (in)	N/A	N/A	DWS Contrast?	N/A
N/A	Landing Slope (%)	N/A	N/A	DWS Length (in)	N/A
N/A	Landing X Slope (%)	N/A	N/A	DWS Full Width?	N/A
N/A	Landing Curb? (Y/N)	N/A	N/A	DWS Offset (in)	N/A
N/A	Shared Landing?	N/A			
N/A	Gutter Ponding?	N/A	N/A	Gutter Slope (%)	N/A
N/A	Gutter Lip Ht (in)	N/A	N/A	Gutter X Slope (%)	N/A
N/A	Painted X Walk1?	Yes	N/A	Painted X Walk2?	Yes
	X Walk 1 Direction	To SE		X Walk 2 Direction	To NE
N/A	X Walk 1 Width (in)	108.0	N/A	X Walk 2 Width (in)	113.0
	X Walk 1 Slope (%)	4.9		X Walk 2 Slope (%)	0.5
	X Walk 1 X Slope (%)	1.5		X Walk 2 X Slope (%)	0.6

N/A	Ramp inside XWalk1?	Yes	N/A	Ramp inside XWalk2?	Yes
	Road Slope (%)	0.0	N/A	Clear Space?	N/A
	Road X Slope (%)	3.3	N/A	Clear Space to XWalk (in)	N/A
N/A	Any Obstructions?	N/A	N/A	Storm Grate/Utility Hazard?	N/A
	Obstruction Type			Storm Grate/Utility Type	
		N/A			N/A
		Yes		Surface Condition? (G/P)	Good

Possible Solutions:

Remove & Replace Curb Ramp With Two New Directional Ramps or Equivalent.

Not Found, R304.2.2
