Access Compliance Report

Public Rights-of-Way (Curb Ramps)

Intersection ID: 21469	Main Street: HOLLY_LN	Cross Street: NEWMANS_LN	Location: NE
ADA ID: 5DFE08EB520B	Ramp Type: PerpDiag	Initial Pass/Fail: Fail	Overall Compliance: No
		Severity Score: 46.25

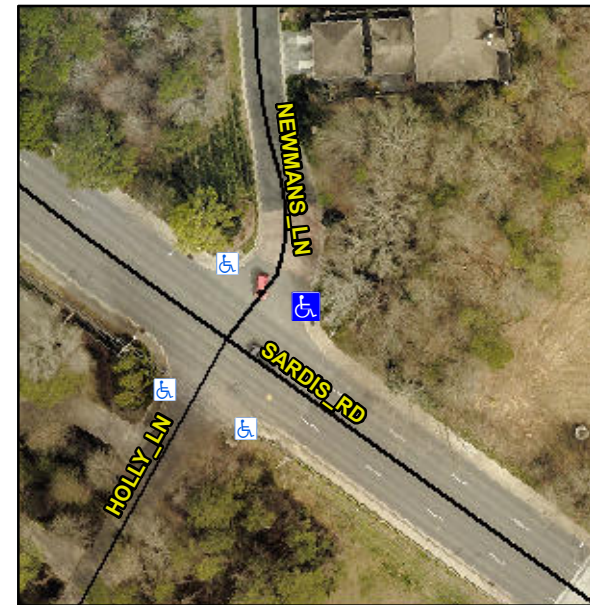
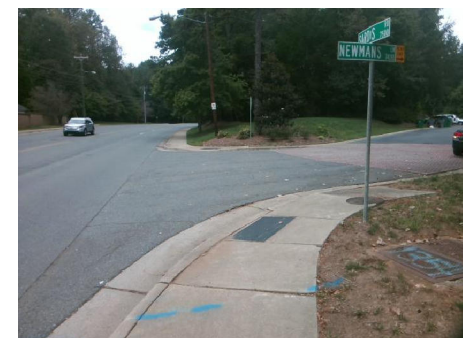
Compliance	Description	Data	Compliance	Description	Data
N/A	Ramp Length (in)	61.0	No	Ramp Slope (%)	11.8
No	Ramp Width (in)	44.0	No	Ramp XSlope (%)	9.5
N/A	Flare Type LT	N/A	N/A	Flare Type RT	N/A
N/A	Flare Slope LT (%)	N/A	N/A	Flare Slope RT (%)	N/A
N/A	Flare Traversable LT?	N/A	N/A	Flare Traversable RT?	N/A
N/A	Landing Length (in)	N/A	N/A	DWS Provided?	N/A
N/A	Landing Width (in)	N/A	N/A	DWS Contrast?	N/A
N/A	Landing Slope (%)	N/A	N/A	DWS Length (in)	N/A
N/A	Landing X Slope (%)	N/A	N/A	DWS Full Width?	N/A
N/A	Landing Curb? (Y/N)	N/A	N/A	DWS Offset (in)	N/A
N/A	Shared Landing?	N/A			
N/A	Gutter Ponding?	N/A	N/A	Gutter Slope (%)	N/A
N/A	Gutter Lip Ht (in)	N/A	N/A	Gutter X Slope (%)	N/A
N/A	Painted X Walk1?	No	N/A	Painted X Walk2?	No
	X Walk 1 Direction	To NW		X Walk 2 Direction	To SW
N/A	X Walk 1 Width (in)	N/A	N/A	X Walk 2 Width (in)	N/A
	X Walk 1 Slope (%)	0.7		X Walk 2 Slope (%)	9.5
	X Walk 1 X Slope (%)	4.7		X Walk 2 X Slope (%)	2.8

N/A	Ramp inside XWalk1?	N/A	N/A	Ramp inside XWalk2?	N/A
	Road Slope (%)	5.5	N/A	Clear Space?	N/A
	Road X Slope (%)	4.1	N/A	Clear Space to XWalk (in)	N/A
N/A	Any Obstructions?	N/A	N/A	Storm Grate/Utility Hazard?	N/A
	Obstruction Type			Storm Grate/Utility Type	
		N/A			N/A
			Yes	Surface Condition? (G/P)	Good

Remove & Replace Curb Ramp With Two New Directional Ramps or Equivalent.

Not Found, R304.5.1, R304.2.2, R304.5.3
