# Access Compliance Report

## Public Rights-of-Way

| Intersection ID: 15045 | Main Street: FAIRWOOD_AV | Cross Street: S_TRYON_ST | Location: W |
| ADA ID: 5E0C888F868A | Ramp Type: PerpDiag | Initial Pass/Fail: Fail | Overall Compliance: No |

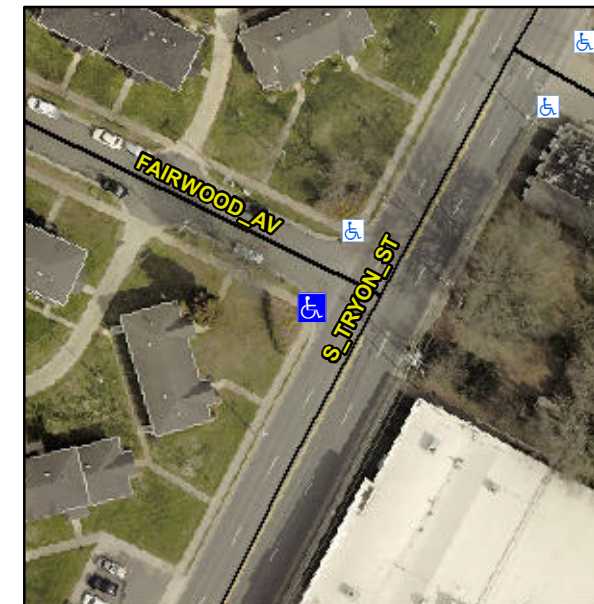
| Severity Score: 13.75 | | | |

**R304.2.2, R304.5.3**

| Compliance | Description | Data | Compliance | Description | Data |
|---|---|---|---|---|---|
| N/A | Ramp Length (in) | 60.5 | No | Ramp Slope (%) | 9.8 |
| Yes | Ramp Width (in) | 48.0 | No | Ramp XSlope (%) | 3.4 |

**Remove & Replace Curb Ramp With Two New Directional Ramps or Equivalent.**

Total Cost: \$ 3200.00
