Access Compliance Report

Public Rights-of-Way

(Curb Ramps)

Intersection ID: 13085	Main Street: MORRIS_FIELD_DR	Cross Street: CAPITOL_DR	Location: SE
ADA ID: 5E11CA018E41	Ramp Type: Perp	Initial Pass/Fail: Fail	Overall Compliance: No
Codes/Mitigation Info/Possible Solution		Field Measurements/Component Compliance	
Severity Score: 21.25

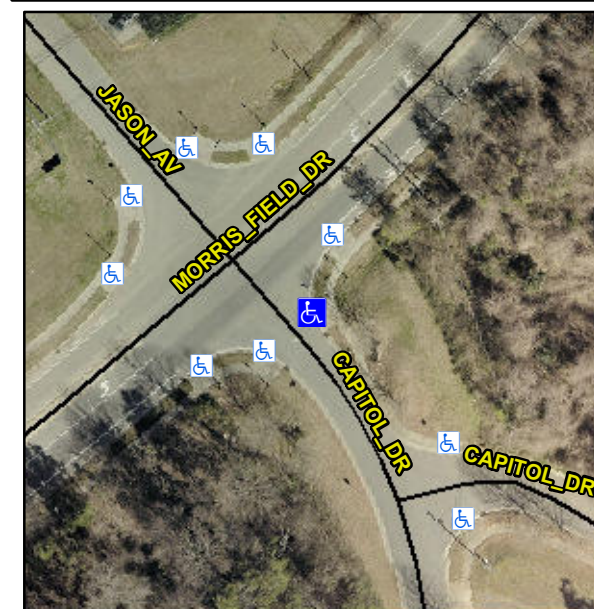
Not Found, R304.5.1, R304.2.2

Compliance	Description	Data	Compliance	Description	Data
N/A	Ramp Length (in)	72.0	No	Ramp Slope (%)	9.4
No	Ramp Width (in)	47.0	Yes	Ramp XSlope (%)	1.8
N/A	Flare Type LT	N/A	N/A	Flare Type RT	N/A
N/A	Flare Slope LT (%)	N/A	N/A	Flare Slope RT (%)	N/A
N/A	Flare Traversable LT?	N/A	N/A	Flare Traversable RT?	N/A
N/A	Landing Length (in)	N/A	N/A	DWS Provided?	N/A
N/A	Landing Width (in)	N/A	N/A	DWS Contrast?	N/A
N/A	Landing Slope (%)	N/A	N/A	DWS Length (in)	N/A
N/A	Landing X Slope (%)	N/A	N/A	DWS Full Width?	N/A
N/A	Landing Curb? (Y/N)	N/A	N/A	DWS Offset (in)	N/A
N/A	Shared Landing?	N/A			
N/A	Gutter Ponding?	N/A	N/A	Gutter Slope (%)	N/A
N/A	Gutter Lip Ht (in)	N/A	N/A	Gutter X Slope (%)	N/A
N/A	Painted X Walk1?	No	N/A	Painted X Walk2?	N/A
	X Walk 1 Direction	To W		X Walk 2 Direction	N/A
N/A	X Walk 1 Width (in)	N/A	N/A	X Walk 2 Width (in)	N/A
	X Walk 1 Slope (%)	0.4		X Walk 2 Slope (%)	N/A
	X Walk 1 X Slope (%)	2.9		X Walk 2 X Slope (%)	N/A

N/A	Ramp inside XWalk1?	N/A	N/A	Ramp inside XWalk2?	N/A
	Road Slope (%)	N/A	N/A	Clear Space?	N/A
	Road X Slope (%)	N/A	N/A	Clear Space to XWalk (in)	N/A
N/A	Any Obstructions?	N/A	N/A	Storm Grate/Utility Hazard?	N/A
	Obstruction Type			Storm Grate/Utility Type	
		N/A			N/A
			Yes	Surface Condition? (G/P)	Good

Remove & Replace Entire Ramp.
