# Access Compliance Report

## Public Rights-of-Way

| Intersection ID: 53914 | Main Street: AMOS_OAKS_LN | Cross Street: BRITTONDALE_LN | Location: S |
| ADA ID: 5E1C17282EFB | Ramp Type: PerpDiag | Initial Pass/Fail: Fail | Overall Compliance: No |

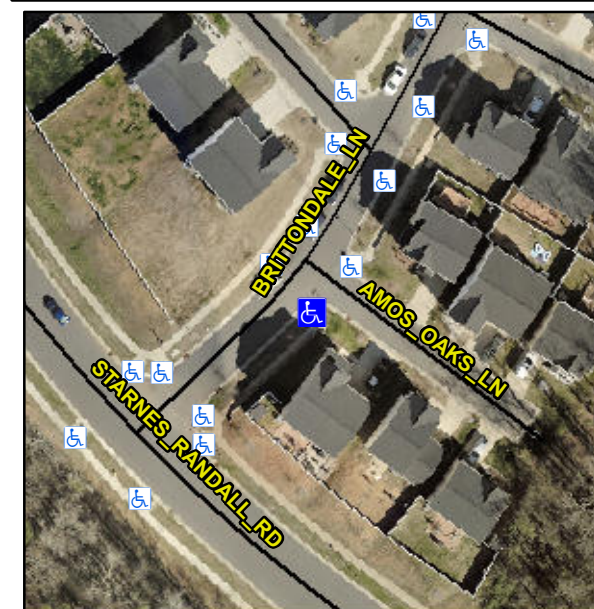
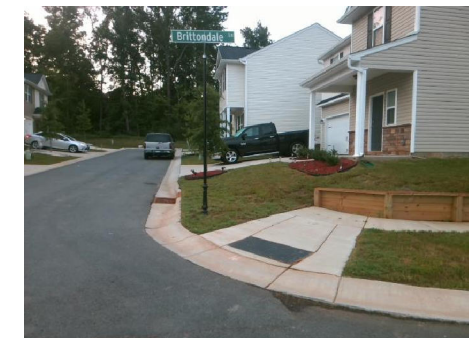
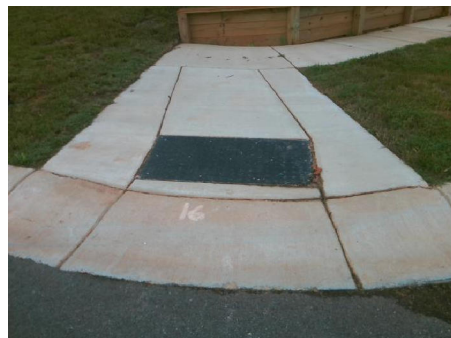
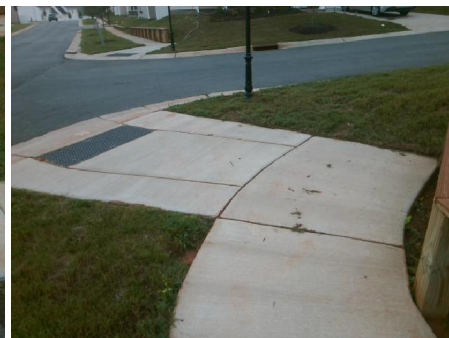
| Severity Score: 21.25 | | | |

**Not Found, R304.5.1, R304.5.3**

| Compliance | Description | Data | Compliance | Description | Data |
|---|---|---|---|---|---|
| N/A | Ramp Length (in) | 100.0 | Yes | Ramp Slope (%) | 6.4 |
| No | Ramp Width (in) | 36.5 | No | Ramp XSlope (%) | 5.4 |

**Remove & Replace Curb Ramp With Two New Directional Ramps or Equivalent.**

Total Cost: \$ 3200.00
