Access Compliance Report

Public Rights-of-Way

(Curb Ramps)

Intersection ID: 10656	Main Street: ASHLEY_RD	Cross Street: LINDBERGH_ST	Location:	N
ADA ID: 5E2747CD99D6	Ramp Type: Perp	Initial Pass/Fail: Fail	Overall Compliance: No	Severity Score: 1.25
Codes/Mitigation Info/Possible Solution		Field Measurements/Component Compliance

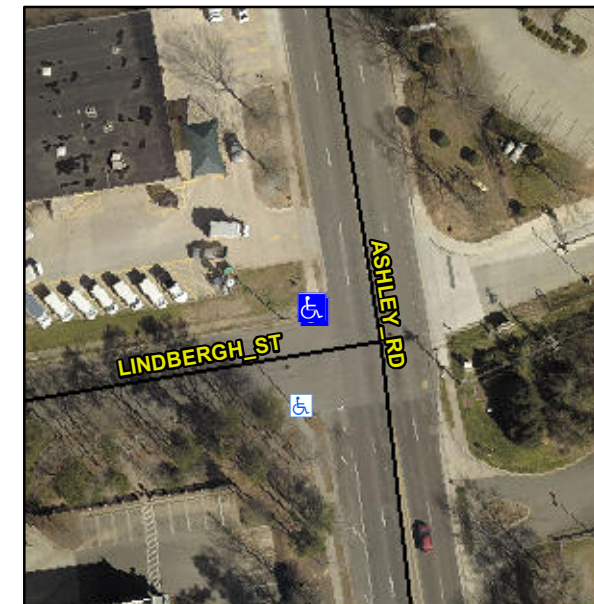
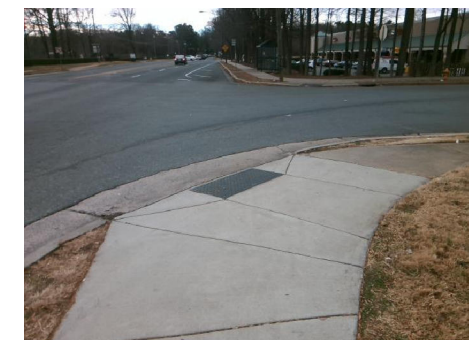
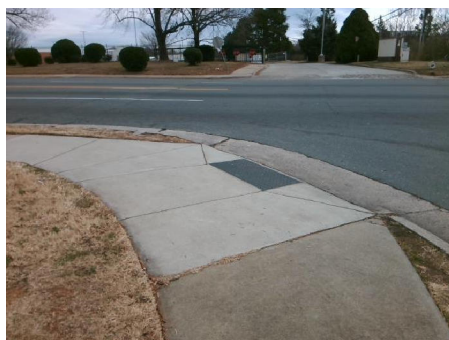
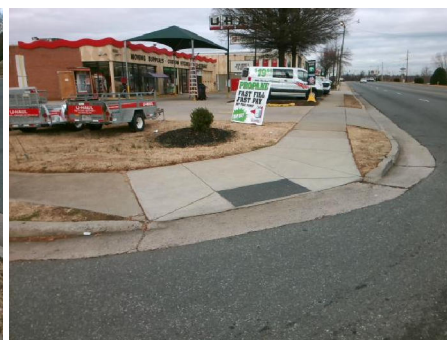
Compliance	Description	Data	Compliance	Description	Data
N/A	Ramp Length (in)	90.0	Yes	Ramp Slope (%)	6.8
Yes	Ramp Width (in)	48.0	No	Ramp XSlope (%)	4.1
N/A	Flare Type LT	N/A	N/A	Flare Type RT	N/A
N/A	Flare Slope LT (%)	N/A	N/A	Flare Slope RT (%)	N/A
N/A	Flare Traversable LT?	N/A	N/A	Flare Traversable RT?	N/A
N/A	Landing Length (in)	N/A	N/A	DWS Provided?	N/A
N/A	Landing Width (in)	N/A	N/A	DWS Contrast?	N/A
N/A	Landing Slope (%)	N/A	N/A	DWS Length (in)	N/A
N/A	Landing X Slope (%)	N/A	N/A	DWS Full Width?	N/A
N/A	Landing Curb? (Y/N)	N/A	N/A	DWS Offset (in)	N/A
N/A	Shared Landing?	N/A			
N/A	Gutter Ponding?	N/A	N/A	Gutter Slope (%)	N/A
N/A	Gutter Lip Ht (in)	N/A	N/A	Gutter X Slope (%)	N/A
N/A	Painted X Walk1?	No	N/A	Painted X Walk2?	N/A
	X Walk 1 Direction	To S		X Walk 2 Direction	N/A
N/A	X Walk 1 Width (in)	N/A	N/A	X Walk 2 Width (in)	N/A
	X Walk 1 Slope (%)	1.0		X Walk 2 Slope (%)	N/A
	X Walk 1 X Slope (%)	2.9		X Walk 2 X Slope (%)	N/A

N/A	Ramp inside XWalk1?	N/A	N/A	Ramp inside XWalk2?	N/A
	Road Slope (%)	N/A	N/A	Clear Space?	N/A
	Road X Slope (%)	N/A	N/A	Clear Space to XWalk (in)	N/A
N/A	Any Obstructions?	N/A	N/A	Storm Grate/Utility Hazard?	N/A
	Obstruction Type			Storm Grate/Utility Type	
		N/A			N/A
			Yes	Surface Condition? (G/P)	Good

Possible Solutions:

Remove & Replace Entire Ramp.

R304.5.3
