# Access Compliance Report

## Public Rights-of-Way

### (Curb Ramps)

Intersection ID: 48492	Main Street: SHOPTON_RD_WEST	Cross Street: BEREWICK_COMMONS_PY	Location: SW
ADA ID: 5E29B4621F83	Ramp Type: Perp	Initial Pass/Fail: Fail	Overall Compliance: No
Severity Score: 12.5			
Codes/Mitigation Info/Possible Solution		Field Measurements/Component Compliance

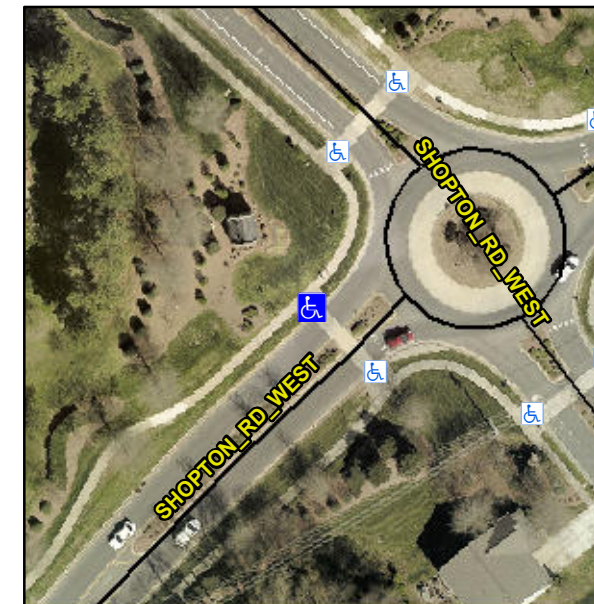
**Not Found, R304.2.2**

Compliance	Description	Data	Compliance	Description	Data
N/A	Ramp Length (in)	70.0	No	Ramp Slope (%)	9.7
Yes	Ramp Width (in)	48.0	Yes	Ramp XSlope (%)	1.0
N/A	Flare Type LT	N/A	N/A	Flare Type RT	N/A
N/A	Flare Slope LT (%)	N/A	N/A	Flare Slope RT (%)	N/A
N/A	Flare Traversable LT?	N/A	N/A	Flare Traversable RT?	N/A
N/A	Landing Length (in)	N/A	N/A	DWS Provided?	N/A
N/A	Landing Width (in)	N/A	N/A	DWS Contrast?	N/A
N/A	Landing Slope (%)	N/A	N/A	DWS Length (in)	N/A
N/A	Landing X Slope (%)	N/A	N/A	DWS Full Width?	N/A
N/A	Landing Curb? (Y/N)	N/A	N/A	DWS Offset (in)	N/A
N/A	Shared Landing?	N/A			
N/A	Gutter Ponding?	N/A	N/A	Gutter Slope (%)	N/A
N/A	Gutter Lip Ht (in)	N/A	N/A	Gutter X Slope (%)	N/A
N/A	Painted X Walk1?	Yes	N/A	Painted X Walk2?	N/A
	X Walk 1 Direction	To SE		X Walk 2 Direction	N/A
N/A	X Walk 1 Width (in)	98.0	N/A	X Walk 2 Width (in)	N/A
	X Walk 1 Slope (%)	1.0		X Walk 2 Slope (%)	N/A
	X Walk 1 X Slope (%)	0.6		X Walk 2 X Slope (%)	N/A

N/A	Ramp inside XWalk1?	Yes	N/A	Ramp inside XWalk2?	N/A
	Road Slope (%)	N/A	N/A	Clear Space?	N/A
	Road X Slope (%)	N/A	N/A	Clear Space to XWalk (in)	N/A
N/A	Any Obstructions?	N/A	N/A	Storm Grate/Utility Hazard?	N/A
	Obstruction Type			Storm Grate/Utility Type	
		N/A			N/A
			Yes	Surface Condition? (G/P)	Good

Possible Solutions:

**Remove & Replace Entire Ramp.**
