# Access Compliance Report

## Public Rights-of-Way

### (Curb Ramps)

Intersection ID: 31183	Main Street: BARBEE_DR	Cross Street: FIELDSTONE_CT	Location: NE
ADA ID: 5E2A600A2896	Ramp Type: PerpDiag	Initial Pass/Fail: Fail	Overall Compliance: No
Codes/Mitigation Info/Possible Solution		Field Measurements/Component Compliance	
Severity Score: 30

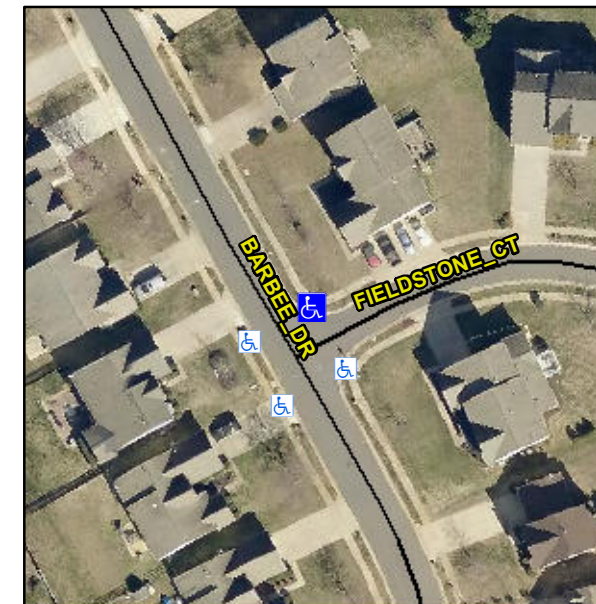
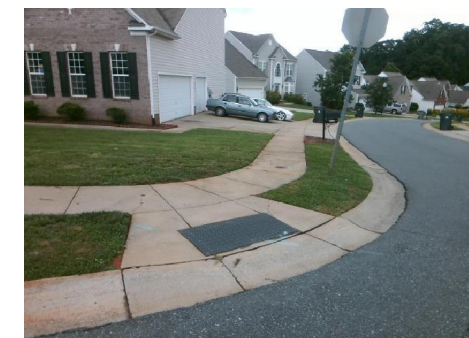
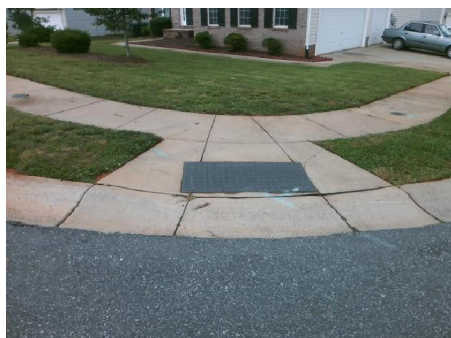
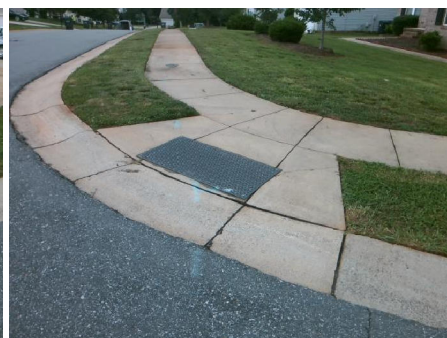
Compliance	Description	Data	Compliance	Description	Data
N/A	Ramp Length (in)	49.0	Yes	Ramp Slope (%)	5.2
No	Ramp Width (in)	33.0	No	Ramp XSlope (%)	5.1
N/A	Flare Type LT	N/A	N/A	Flare Type RT	N/A
N/A	Flare Slope LT (%)	N/A	N/A	Flare Slope RT (%)	N/A
N/A	Flare Traversable LT?	N/A	N/A	Flare Traversable RT?	N/A
N/A	Landing Length (in)	N/A	N/A	DWS Provided?	N/A
N/A	Landing Width (in)	N/A	N/A	DWS Contrast?	N/A
N/A	Landing Slope (%)	N/A	N/A	DWS Length (in)	N/A
N/A	Landing X Slope (%)	N/A	N/A	DWS Full Width?	N/A
N/A	Landing Curb? (Y/N)	N/A	N/A	DWS Offset (in)	N/A
N/A	Shared Landing?	N/A			
N/A	Gutter Ponding?	N/A	N/A	Gutter Slope (%)	N/A
N/A	Gutter Lip Ht (in)	1.5	N/A	Gutter X Slope (%)	N/A
N/A	Painted X Walk1?	No	N/A	Painted X Walk2?	No
	X Walk 1 Direction	To W		X Walk 2 Direction	To S
N/A	X Walk 1 Width (in)	N/A	N/A	X Walk 2 Width (in)	N/A
	X Walk 1 Slope (%)	4.0		X Walk 2 Slope (%)	0.2
	X Walk 1 X Slope (%)	1.1		X Walk 2 X Slope (%)	8.7

N/A	Ramp inside XWalk1?	N/A	N/A	Ramp inside XWalk2?	N/A
	Road Slope (%)	6.1	N/A	Clear Space?	N/A
	Road X Slope (%)	5.9	N/A	Clear Space to XWalk (in)	N/A
N/A	Any Obstructions?	N/A	N/A	Storm Grate/Utility Hazard?	N/A
	Obstruction Type			Storm Grate/Utility Type	
		N/A			N/A
		Yes		Surface Condition? (G/P)	Good

**Remove & Replace Curb Ramp With Two New Directional Ramps or Equivalent.**

**R304.5.1, R304.5.3**
