# Access Compliance Report

## Public Rights-of-Way

### (Curb Ramps)

Intersection ID: 45510	Main Street: WOODLAND_WATCH_CT	Cross Street: MEADOW_BOTTOM_RD	Location: SE
ADA ID: 5E35C90458BB	Ramp Type: PerpDiag	Initial Pass/Fail: Fail	Overall Compliance: No
Severity Score: 13.75			
Codes/Mitigation Info/Possible Solution		Field Measurements/Component Compliance

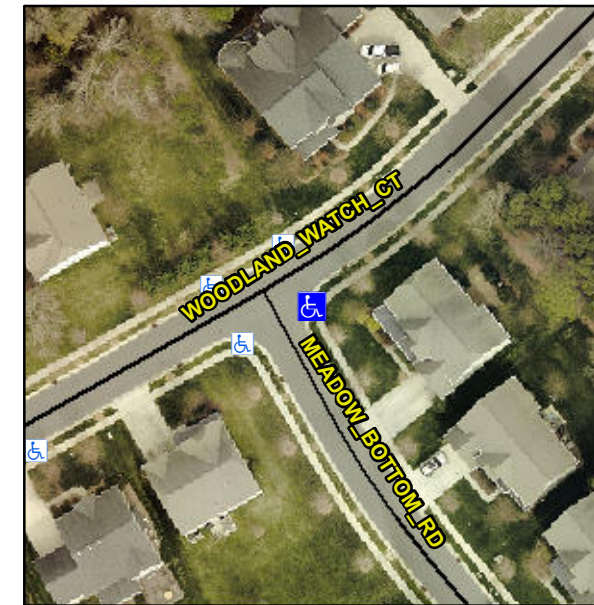
**Not Found, R304.2.2, R304.5.3**

Compliance	Description	Data	Compliance	Description	Data
N/A	Ramp Length (in)	48.0	No	Ramp Slope (%)	10.2
Yes	Ramp Width (in)	48.0	No	Ramp XSlope (%)	2.5
N/A	Flare Type LT	N/A	N/A	Flare Type RT	N/A
N/A	Flare Slope LT (%)	N/A	N/A	Flare Slope RT (%)	N/A
N/A	Flare Traversable LT?	N/A	N/A	Flare Traversable RT?	N/A
N/A	Landing Length (in)	N/A	N/A	DWS Provided?	N/A
N/A	Landing Width (in)	N/A	N/A	DWS Contrast?	N/A
N/A	Landing Slope (%)	N/A	N/A	DWS Length (in)	N/A
N/A	Landing X Slope (%)	N/A	N/A	DWS Full Width?	N/A
N/A	Landing Curb? (Y/N)	N/A	N/A	DWS Offset (in)	N/A
N/A	Shared Landing?	N/A			
N/A	Gutter Ponding?	N/A	N/A	Gutter Slope (%)	N/A
N/A	Gutter Lip Ht (in)	N/A	N/A	Gutter X Slope (%)	N/A
N/A	Painted X Walk1?	No	N/A	Painted X Walk2?	No
	X Walk 1 Direction	To NW		X Walk 2 Direction	To SW
N/A	X Walk 1 Width (in)	N/A	N/A	X Walk 2 Width (in)	N/A
	X Walk 1 Slope (%)	3.7		X Walk 2 Slope (%)	0.7
	X Walk 1 X Slope (%)	1.2		X Walk 2 X Slope (%)	4.2

N/A	Ramp inside XWalk1?	N/A	N/A	Ramp inside XWalk2?	N/A
	Road Slope (%)	3.4	N/A	Clear Space?	N/A
	Road X Slope (%)	2.9	N/A	Clear Space to XWalk (in)	N/A
N/A	Any Obstructions?	N/A	N/A	Storm Grate/Utility Hazard?	N/A
	Obstruction Type			Storm Grate/Utility Type	
		N/A			N/A
		Yes		Surface Condition? (G/P)	Good

**Remove & Replace Curb Ramp With Two New Directional Ramps or Equivalent.**

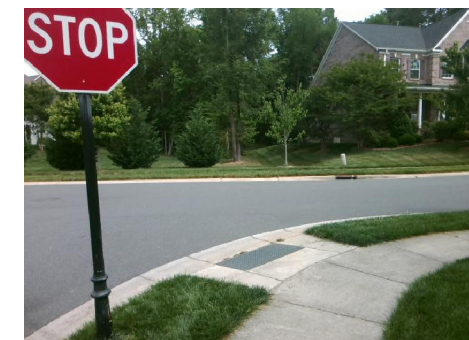
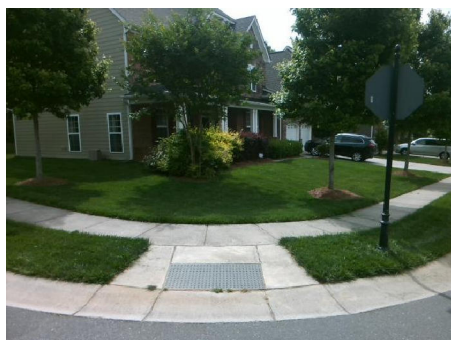
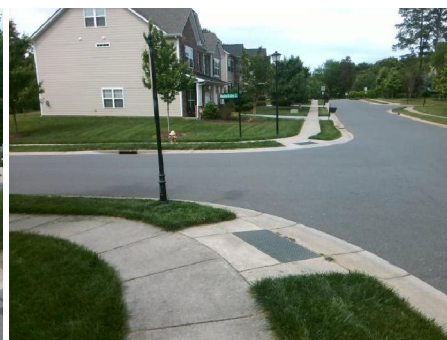
Street 1 Name WOODLAND WATCH CT  
 Stop Condition-Street 2 None  
 Street 2 Name MEADOW BOTTOM RD  
 Stop Condition-Street 1 StopSign
