# Access Compliance Report

## Public Rights-of-Way

### (Curb Ramps)

Intersection ID: 11972	Main Street: N_POPLAR_ST	Cross Street: W_5TH_ST	Location: S
ADA ID: 5E3FF27B9500	Ramp Type: PerpDiag	Initial Pass/Fail: Pass	Overall Compliance: No
			Severity Score: 10.25

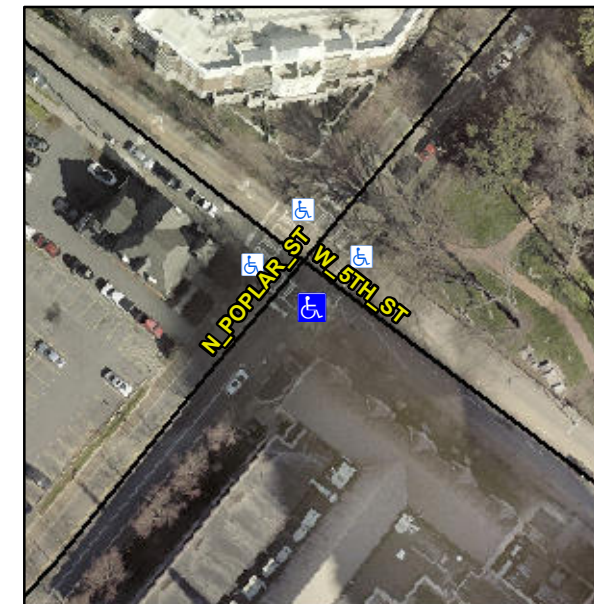
Compliance	Description	Data	Compliance	Description	Data
N/A	Ramp Length (in)	54.0	Yes	Ramp Slope (%)	7.2
Yes	Ramp Width (in)	53.0	Yes	Ramp XSlope (%)	2.4
N/A	Flare Type LT	Sloped	N/A	Flare Type RT	N/A
N/A	Flare Slope LT (%)	9.1	N/A	Flare Slope RT (%)	9.3
N/A	Flare Traversable LT?	No	N/A	Flare Traversable RT?	No
Yes	Landing Length (in)	60.0	No	DWS Provided?	No
Yes	Landing Width (in)	60.0	N/A	DWS Contrast?	No
No	Landing Slope (%)	4.9	N/A	DWS Length (in)	N/A
Yes	Landing X Slope (%)	0.7	N/A	DWS Full Width?	No
N/A	Landing Curb? (Y/N)	No	N/A	DWS Offset (in)	N/A
N/A	Shared Landing?	No			
Yes	Gutter Ponding?	No	Yes	Gutter Slope (%)	1.6
Yes	Gutter Lip Ht (in)	0.0	Yes	Gutter X Slope (%)	0.4
N/A	Painted X Walk1?	Yes	N/A	Painted X Walk2?	Yes
	X Walk 1 Direction	To NE		X Walk 2 Direction	To NW
N/A	X Walk 1 Width (in)	113.0	N/A	X Walk 2 Width (in)	113.0
	X Walk 1 Slope (%)	0.9		X Walk 2 Slope (%)	3.2
	X Walk 1 X Slope (%)	0.7		X Walk 2 X Slope (%)	0.1

Yes	Ramp inside XWalk1?	Yes	Yes	Ramp inside XWalk2?	Yes
	Road Slope (%)	3.1	N/A	Clear Space?	Yes
	Road X Slope (%)	0.8	No	Clear Space to XWalk (in)	26.0
Yes	Any Obstructions?	No	Yes	Storm Grate/Utility Hazard?	No
	Obstruction Type			Storm Grate/Utility Type	
			N/A		N/A
			Yes	Surface Condition? (G/P)	Good

Possible Solutions:

**Remove & Replace Curb Ramp With Two New Directional Ramps or Equivalent. Restripe Crosswalk(s) To Provide Clear space.**

**Not Found, R304.2.2-Perp, R304.3.2-Para, R305**
