# Access Compliance Report

## Public Rights-of-Way

### (Curb Ramps)

Intersection ID: 43116	Main Street: CENTRAL_AV	Cross Street: PECAN_AV	Location: SW
ADA ID: 5E499661AEBD	Ramp Type: Perp	Initial Pass/Fail: Fail	Overall Compliance: No
		Severity Score: 12.5

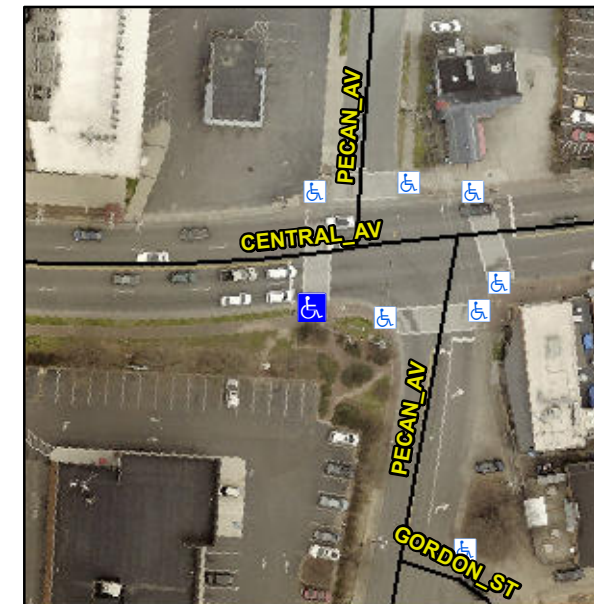
**Not Found, R304.2.2**

Compliance	Description	Data	Compliance	Description	Data
N/A	Ramp Length (in)	55.0	No	Ramp Slope (%)	8.5
Yes	Ramp Width (in)	48.0	Yes	Ramp XSlope (%)	1.6
N/A	Flare Type LT	N/A	N/A	Flare Type RT	N/A
N/A	Flare Slope LT (%)	N/A	N/A	Flare Slope RT (%)	N/A
N/A	Flare Traversable LT?	N/A	N/A	Flare Traversable RT?	N/A
N/A	Landing Length (in)	N/A	N/A	DWS Provided?	N/A
N/A	Landing Width (in)	N/A	N/A	DWS Contrast?	N/A
N/A	Landing Slope (%)	N/A	N/A	DWS Length (in)	N/A
N/A	Landing X Slope (%)	N/A	N/A	DWS Full Width?	N/A
N/A	Landing Curb? (Y/N)	N/A	N/A	DWS Offset (in)	N/A
N/A	Shared Landing?	N/A			
N/A	Gutter Ponding?	N/A	N/A	Gutter Slope (%)	N/A
N/A	Gutter Lip Ht (in)	N/A	N/A	Gutter X Slope (%)	N/A
N/A	Painted X Walk1?	Yes	N/A	Painted X Walk2?	N/A
	X Walk 1 Direction	To N		X Walk 2 Direction	N/A
N/A	X Walk 1 Width (in)	143.5	N/A	X Walk 2 Width (in)	N/A
	X Walk 1 Slope (%)	4.4		X Walk 2 Slope (%)	N/A
	X Walk 1 X Slope (%)	0.9		X Walk 2 X Slope (%)	N/A

N/A	Ramp inside XWalk1?	Yes	N/A	Ramp inside XWalk2?	N/A
	Road Slope (%)	N/A	N/A	Clear Space?	N/A
	Road X Slope (%)	N/A	N/A	Clear Space to XWalk (in)	N/A
N/A	Any Obstructions?	N/A	N/A	Storm Grate/Utility Hazard?	N/A
	Obstruction Type			Storm Grate/Utility Type	
		N/A			N/A
		Yes		Surface Condition? (G/P)	Good

**Remove & Replace Entire Ramp.**

Total Cost: \$ 1850.00
