# Access Compliance Report

## Public Rights-of-Way

Intersection ID: 23368	Main Street: S_TRYON_ST	Cross Street: SOUTH_POINT_BV	Location: SE
ADA ID: 5E4A125D63D0	Ramp Type: Perp	Initial Pass/Fail: Pass	Overall Compliance: No
			Severity Score: 2.5

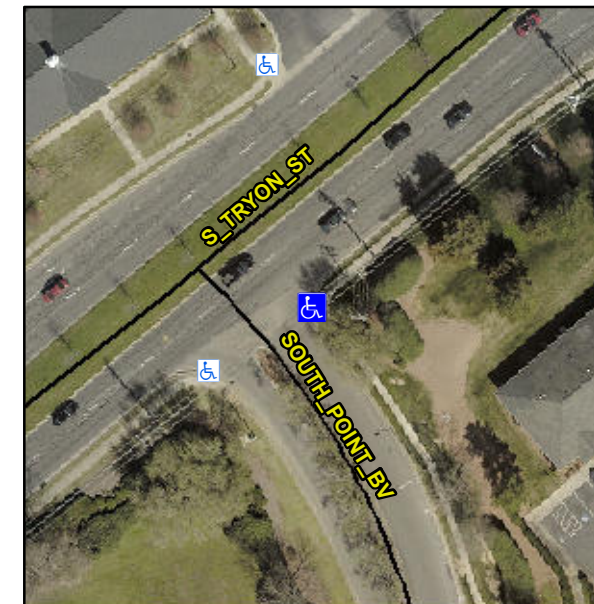
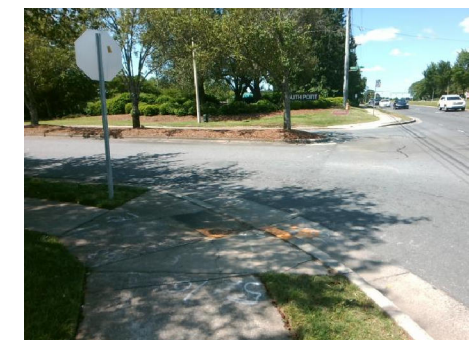
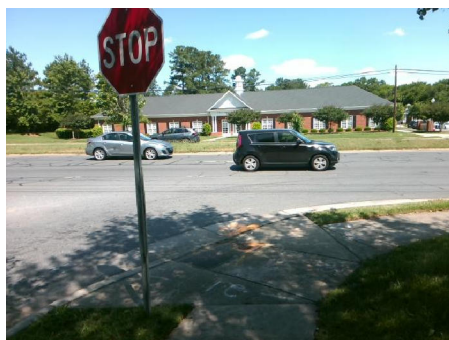
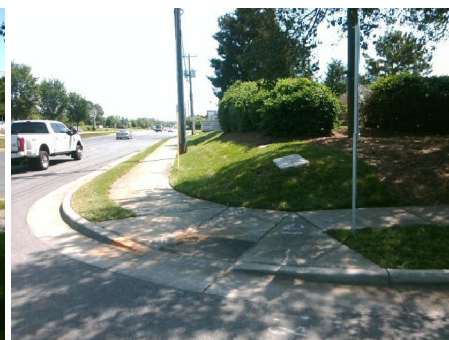
**Remove & Replace Entire Ramp.  
Gutter Ponding Observed.**

Compliance	Description	Data	Compliance	Description	Data
N/A	Ramp Length (in)	66.0	Yes	Ramp Slope (%)	7.6
Yes	Ramp Width (in)	48.0	Yes	Ramp XSlope (%)	2.0
N/A	Flare Type LT	Sloped	N/A	Flare Type RT	N/A
N/A	Flare Slope LT (%)	7.4	Yes	Flare Slope RT (%)	5.6
N/A	Flare Traversable LT?	Yes	N/A	Flare Traversable RT?	Yes
No	Landing Length (in)	24.0	Yes	DWS Provided?	Yes
Yes	Landing Width (in)	48.0	Yes	DWS Contrast?	Yes
Yes	Landing Slope (%)	1.6	Yes	DWS Length (in)	24.0
Yes	Landing X Slope (%)	0.5	No	DWS Full Width?	No
N/A	Landing Curb? (Y/N)	No	No	DWS Offset (in)	6.0
N/A	Shared Landing?	No			
No	Gutter Ponding?	Yes	Yes	Gutter Slope (%)	2.9
Yes	Gutter Lip Ht (in)	0.0	Yes	Gutter X Slope (%)	0.2
N/A	Painted X Walk1?	No	N/A	Painted X Walk2?	N/A
	X Walk 1 Direction	To W		X Walk 2 Direction	N/A
N/A	X Walk 1 Width (in)	N/A	N/A	X Walk 2 Width (in)	N/A
	X Walk 1 Slope (%)	0.3		X Walk 2 Slope (%)	N/A
	X Walk 1 X Slope (%)	1.9		X Walk 2 X Slope (%)	N/A

N/A	Ramp inside XWalk1?	N/A	N/A	Ramp inside XWalk2?	N/A
	Road Slope (%)	N/A	N/A	Clear Space?	Yes
	Road X Slope (%)	N/A	N/A	Clear Space to XWalk (in)	N/A
Yes	Any Obstructions?	No	Yes	Storm Grate/Utility Hazard?	No
	Obstruction Type			Storm Grate/Utility Type	
		N/A			N/A
			Yes	Surface Condition? (G/P)	Good

**R304.2.1, R305.1.4, R305.2, R302.7**
