# Access Compliance Report

## Public Rights-of-Way

### (Curb Ramps)

| Intersection ID: 14486 | Main Street: MAIN_ST | Cross Street: N/A | Location: W |

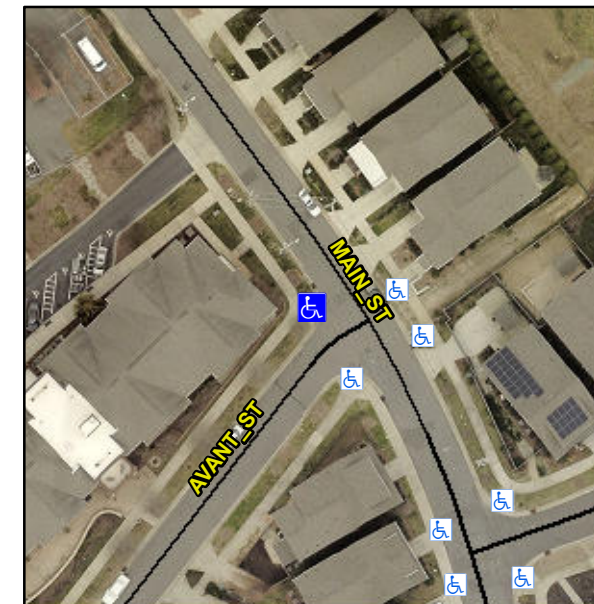
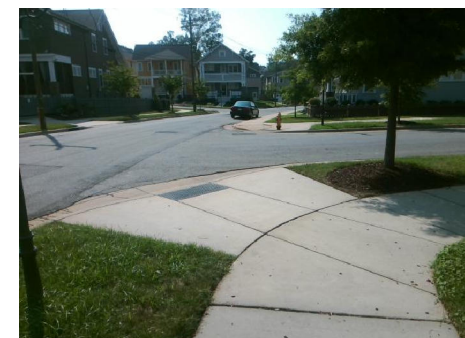
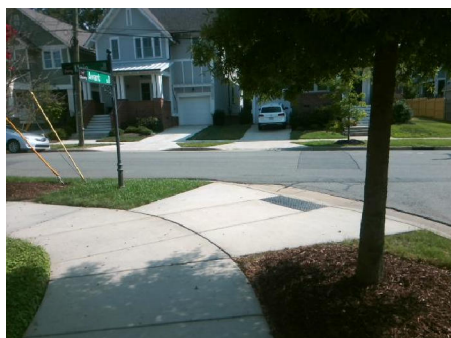
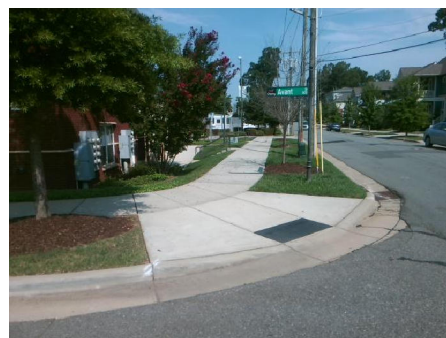
| ADA ID: 5E4B2FEB1128 | Ramp Type: BlendTrans1 | Initial Pass/Fail: Fail | Overall Compliance: No |

| Severity Score: 8.75 | | | |

**R304.5.1**

| Compliance | Description | Data | Compliance | Description | Data |
|---|---|---|---|---|---|
| No | Ramp Width (in) | 46.0 | Yes | BlendTrans XSlope (%) | 1.2 |

Possible Solutions:

**Remove & Replace Curb Ramp With Two New Directional Ramps or Equivalent.**

**\$ 3200.00**
